The 1786 earthquake-triggered landslide dam and subsequent dam-break flood on the Dadu River, southwestern China

F.C. Dai^{a,b}, C.F. Lee^{b,*}, J.H. Deng^c, L.G. Tham^b

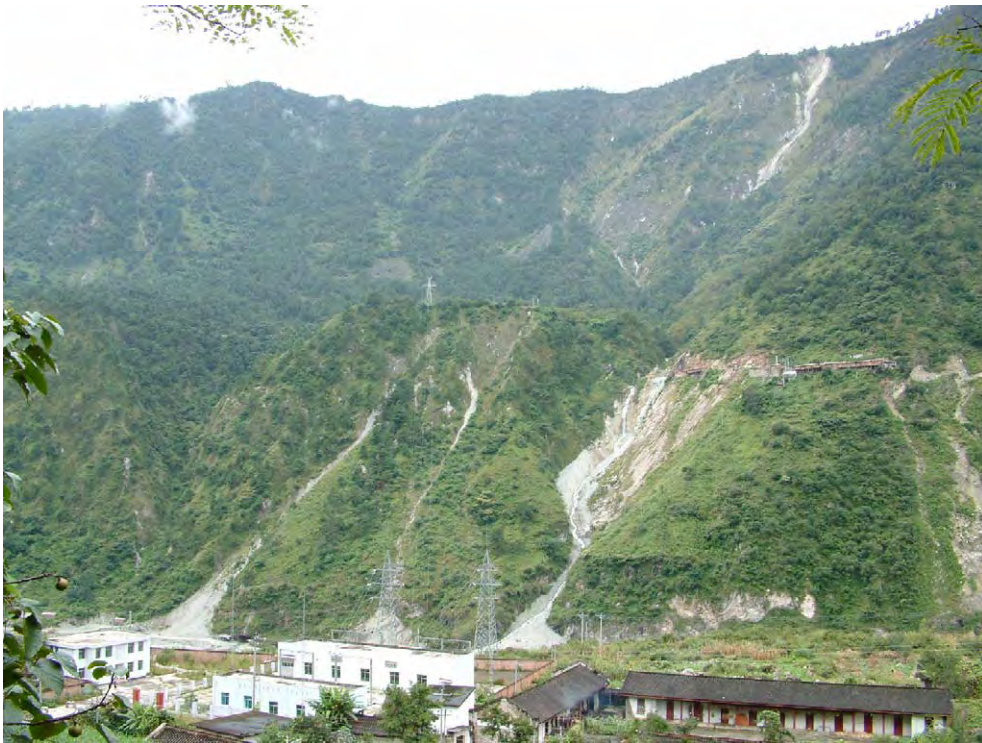
Fig. 5. Photograph showing the location which was interpreted as the landslide site by the Institute of Geophysics at the National Seismological Bureau and Institute of Chinese Historic Geography at Fudan University (1990) (view is to the west). The location of the site is shown in Fig. 7.

We searched all published materials associated with the possible location of the landslide and found a photograph taken in 1984, which was considered to represent the landslide site, in the *Atlas of Historic Earthquakes in China for the Qing Dynasty Period* (Institute of Geophysics at the National Seismological Bureau and Institute of Chinese Historic Geography at Fudan University, 1990). The location, as then photographed, was found in the field in August 2003 (Fig. 5). A detailed walkover survey was then carried out, and it was found that the landslide could not have taken place there on the grounds that (a) a gentle terrace surface with slope angles less than 5° can be seen, and it seems to be composed of glacial deposits (Sichuan Bureau of Geology and Mineral Resources, 1991), although slope deposits originating from small-scale rockfalls occur on steep slopes behind the terrace; (b) the bedrock, although heavily fractured, was consistently exposed along the eph-

eral streamlines on slopes; and (c) no remnants of the landslide debris can be found on the opposite bank. We then checked all other possible locations, conducting a walkover survey from Lengqi to Qianwan along the Dadu River (Fig. 4). We found that although numerous small-scale rockfalls and landslides could readily be observed on both banks of the Dadu River, a site on the right bank (Fig. 6) was the only sizable landslide that could dam the Dadu River. This landslide is adjacent to the site in Fig. 5 and lies within MMI zone IX of the 1786 earthquake.

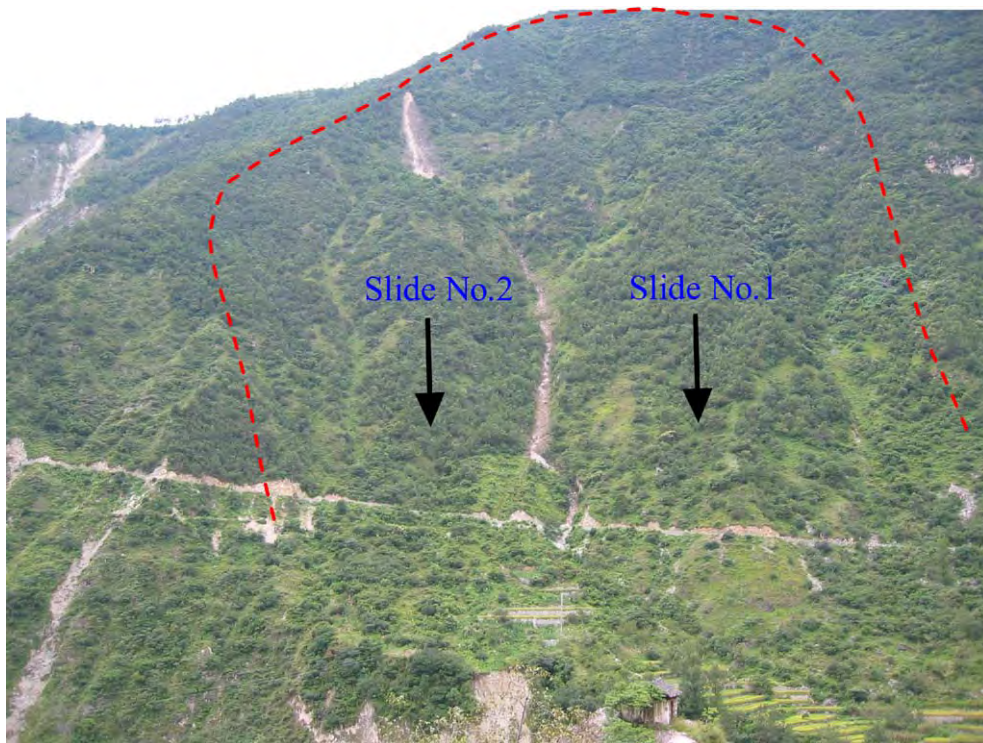
Geomorphic and geologic features of the landslide site are illustrated in a diagrammatic map of the landslide area (Fig. 7). Two adjoining hummocky slide masses can be seen above the steep right bank of the Dadu River. The landslide area is bush covered, marked by an active debris avalanche scar. The landslide is bounded to the north and the south by two ephemeral drainage lines and separated into two parts by a drainage line along which the recent debris avalanche moved downslope (Fig. 6). It can be

Fig. 6. Photograph showing the landslide site (view is to the west). The failure main scarp is marked with a dashed line, and the location of the site is shown in Fig. 4.

observed that the loose materials deposited along the drainage line were entrained during debris movement, exposing the underlying bedrock. It may be reasonable to divide the landslide into Slide no. 1 and Slide no. 2 as possibly two phases of movement (Fig. 7) because both slides are inferred to have a deep shear surface from the geomorphic features of the main landslide scar and the exposed bedrock on the drainage line. At the back of the landslide mass, a huge displaced rock block was sandwiched between these two slide masses. Apart from the minor erosion scar that constitutes the source area of the recent debris flow, no scarp shows evidence of active slope movements.

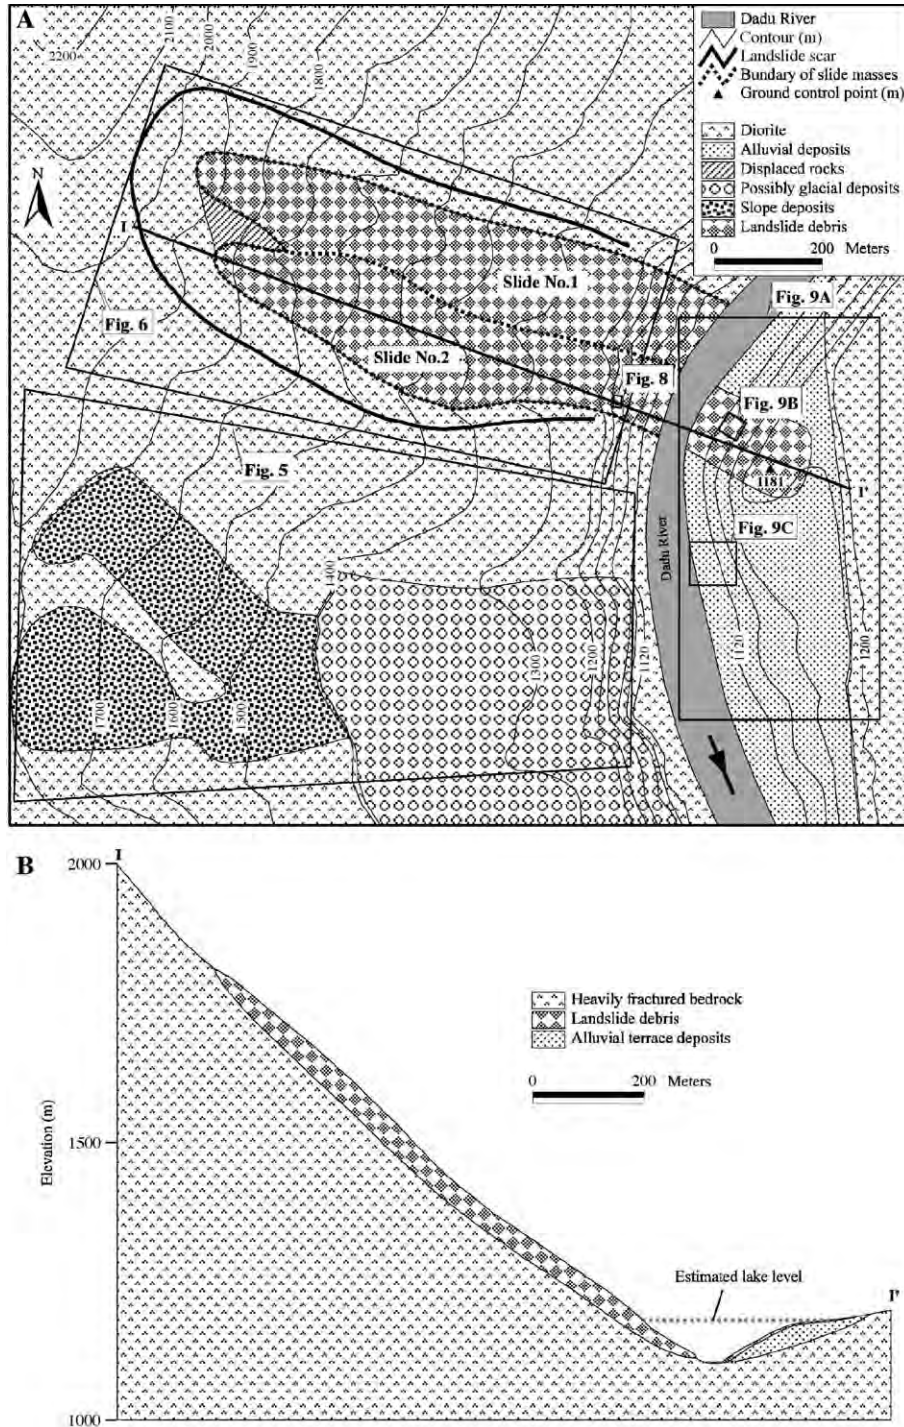
Fig. 7. Sketch map showing the geomorphology and geology of the landslide site and the spatial relation of Figs. 5, 6, 8 and 9, (A) plan; (B) cross-section of I-I'.

The slope of the landslide area ranges from 35° to 40° , whereas the Dadu River has a gradient of about 1%, traversing a narrow and steep-walled valley. The width of the riverbed at the landslide site is estimated to be about 80 m. The geology of the landslide area is comprised mainly of diorite of the Archean–early Proterozoic age (Fig. 7). The bedrock is heavily fractured due to structural and weathering effects. On

the left bank, two terrace levels composed of alluvial sands, gravels and boulders can be distinguished. The river turns right and erodes the toe of Slide no. 2. The intense undercutting and lateral erosion of the river water makes the riverbank very steep, with an estimated slope angle of 50° – 60° . The landslide debris consists predominantly of extremely crushed materials, ranging in particle size from clays to boulders and rock fragments (Fig. 8). It appears that both Slide no. 1 and Slide no. 2 occurred within heavily fractured diorite and slid along a steeply inclined slip surface (Fig. 7B). The volume is approximately $5 \times 10^6 \text{ m}^3$ for Slide no. 2, and $6 \times 10^6 \text{ m}^3$ for Slide no. 1, if the average failure depth is assumed to be 35 m based on the topographic features of the main landslide scar.

From the geomorphic features of the landslide area, it appears that the distal part of Slide no. 2 released a significant volume of landslide debris into the valley of the Dadu River and dammed the river completely, whereas the remainder of the debris remained stuck on the valley side, forming a hummocky accumulation.

Although there is no geomorphic evidence indicating that this landslide is still active, it has not yet reached the position of minimum potential energy

(Fig. 7). Hence, it is possible for the landslide to be reactivated under strong shaking conditions. These are the following four external and internal factors that may contribute to the future reactivation of the landslide. The first factor is the erosion of flowing water at the toe of the landslide. The Dadu River continuously and directly erodes the toe of Slide no. 2, removing the lateral support from an oversteepened slope. The second factor is that the shear strength of the sheared surface has been drastically reduced to the residual state due to past landsliding, increasing the possibility of future reactivation, as the heavily fractured bedrock has been extremely crushed or even powdered during the past movement. The third factor is that the head scarp of the landslide seems to show, albeit minor, symptoms of instability, and the possibility of new rockfalls from the cliffs should be considered, particularly under seismic conditions. The last factor is the possibility of future earthquakes. Based on seismological study, there are three near-site potential seismic sources that may produce strong earthquakes: (a) the Zheduotang and Selaha faults, (b) the Yalahe fault, and (c) the Moxi fault. For the Yalahe fault, the recurrence interval of strong earthquake with $M \geq 6.0$ exceeds 1000 years, and the last strong earthquake on this fault is estimated to have occurred in 1380 ± 60 AD (Zhou et al., 2001). The possibility of strong earthquakes on this fault in the coming 100 years is thus very low. The same applies to the Zheduotang and Selaha faults because the strong earthquake ($M \geq 6.0$) recurrence interval of these faults is 230 to 350 years (Zhou et al., 2001), and the last strong earthquake occurred in 1955. However, the Moxi fault will induce a strong earthquake in the coming 100 years because the strong earthquake recurrence interval on this fault is about 300 years, and the last strong earthquake occurred in 1786, which generated the landslide dam under study. In conclusion, it is possible for the landslide to be reactivated in the near future.

Reactivation of the landslide, if it does occur, will block the Dadu River again, as the oversteepened distal part of Slide no. 2 has already reached the riverbed, and the river course is narrow. Elements at risk include the residents and buildings on the opposite bank, as well as those in upstream and downstream areas. Detailed geotechnical investigations for evaluating the stability of the landslide are

strongly recommended with due consideration for future seismic risk.

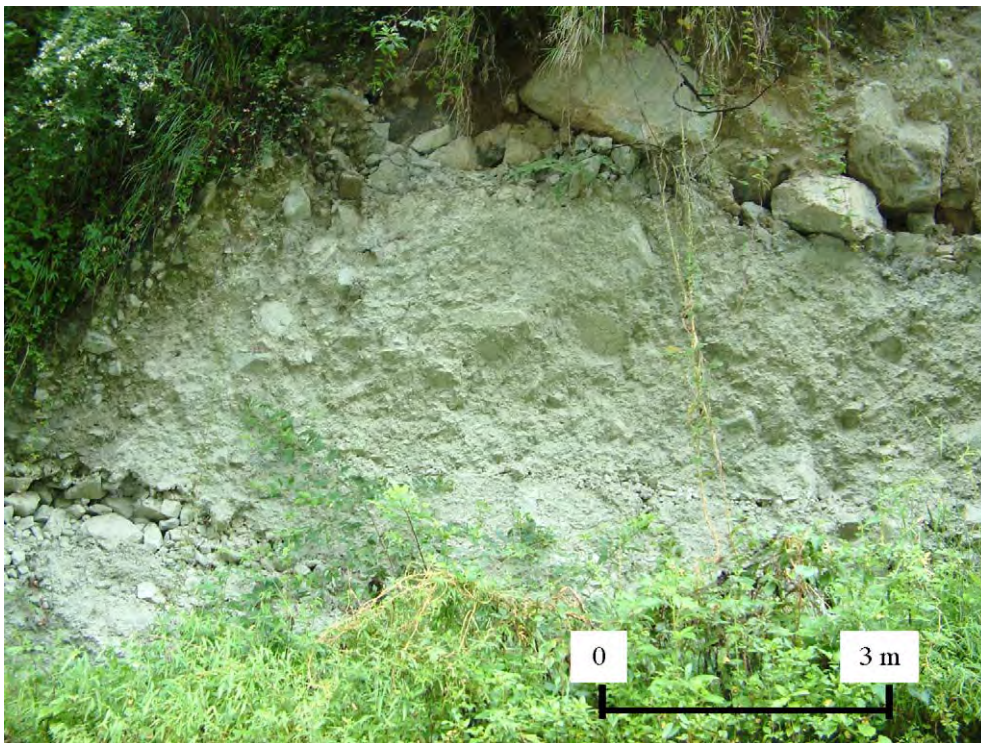
Fig. 8. Photograph showing the landslide debris on the right bank (view is to the west).

This can be verified by the fact that on the opposite bank of Slide no. 2, the remnants of landslide debris can be clearly observed, which can be distinguished from the upstream and downstream boulders and sands of alluvial origin (Fig. 9). The remnants of landslide debris can be found on the terraces of the left bank, implying that the landslide dam had a height equivalent to the elevation of the terrace. An official ground control point (GCP) for surveying at an elevation of 1181 m is located where the remnants of the landslide debris were observed (Fig. 7). Judging from the deposits, the landslide dam had a length of 320 m at the crest and 80 m at the river level. Schuster and Costa (1986) concluded that in steep-walled

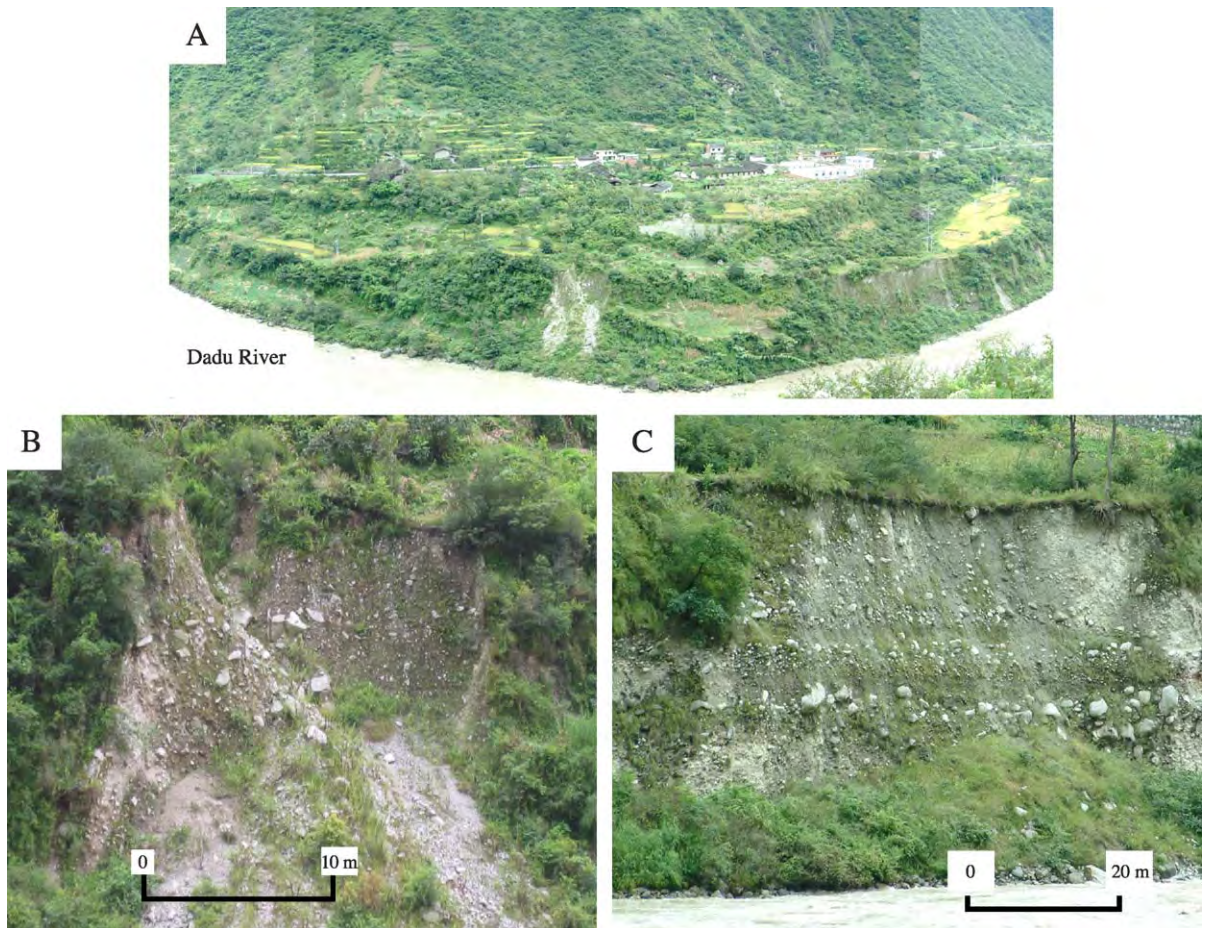
Fig. 9. (A) View of the opposite bank of the landslide (view is to the east). A small fresh bank failure can be observed on the steep-walled bank; (B) remnants of landslide debris on the opposite steep-walled bank exposed due to the small fresh bank failure (view is to the east); (C) alluvial deposits on the opposite steep-walled bank downstream the landslide dam site (view is to the east).

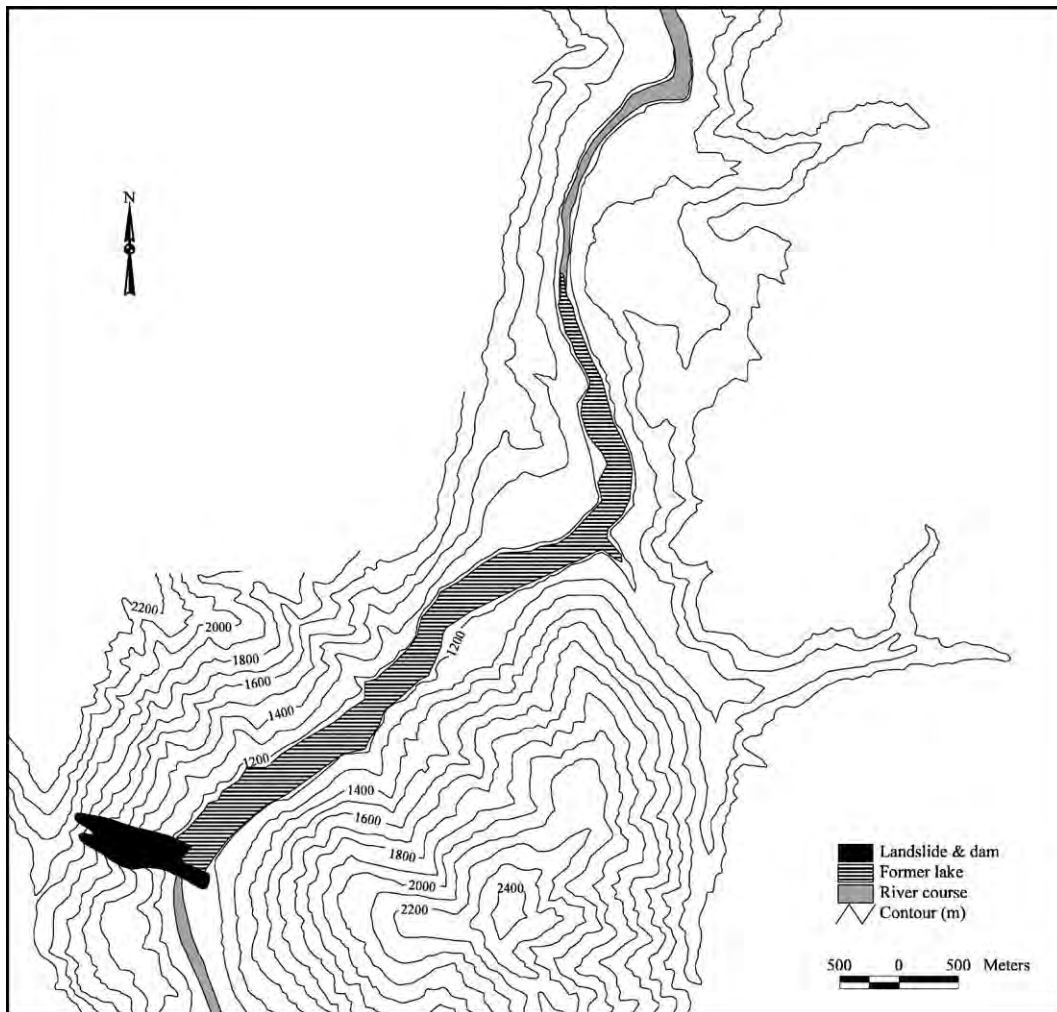
It can be envisaged that after the landslide dam was formed, a reservoir began to develop behind the dam. The 1:50,000-scale topographic map covering the landslide area and its upstream area was digitised and then used to generate the digital elevation model (DEM) data with a resolution of 20 m so that the volume of the reservoir water can be reasonably estimated. Based on the ground control point in Fig. 7, it is reasonable to set the maximum elevation of the lake water as about 1180 m a.s.l. Thus, the reservoir

behind the landslide dam at this elevation was about 6.8 km long along the main valley; the volume and area were estimated to be about $50 \times 10^6 \text{ m}^3$ and 1.7 km^2 , respectively (Fig. 10).

As described on the monument, the lake water overflowed the top of the landslide dam in the early morning of June 9. On June 10, the landslide dam breached suddenly, and the river valley downstream of the dam was flooded. This dam failure was triggered by an aftershock, rather than by overtopping or seepage and piping that are the most common mechanisms of natural dam failures, as described in the *Memoirs of Tianquan Prefecture*

Fig. 10. Map showing the landslide dam site and the lake behind the landslide dam. The lake was reconstructed for a dam crest height of 70 m.
