# Sandy River near Oxbow Park

2014 Bretz Club Field Trip Materials  
Sandy River, Oregon  
April 10-12, 2014  
Multiple Parts  
Multiple Authors  
Not a citable document

# Episodes of Extreme Syneruption Sedimentation in the Lower Sandy River

# Fluvial response to removal of Marmot Dam, Sandy River, Oregon

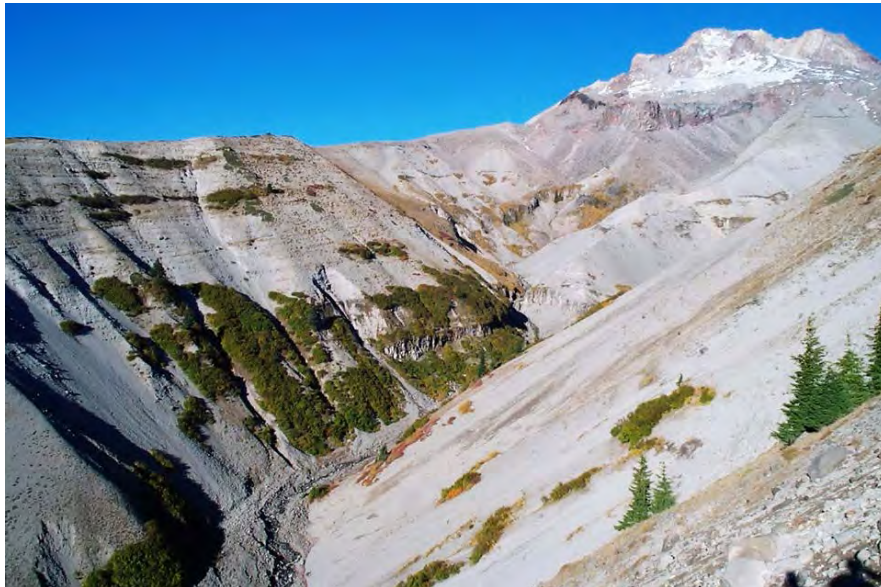
*Figure 1. Source area for sediment on flank of Mount Hood. This debris fan accumulated sediment from numerous small lahars and pyroclastic flows.*

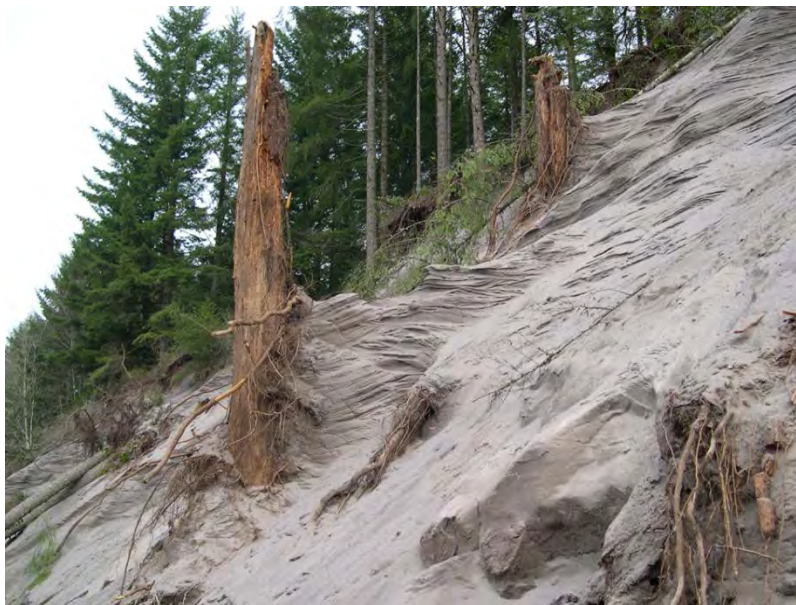
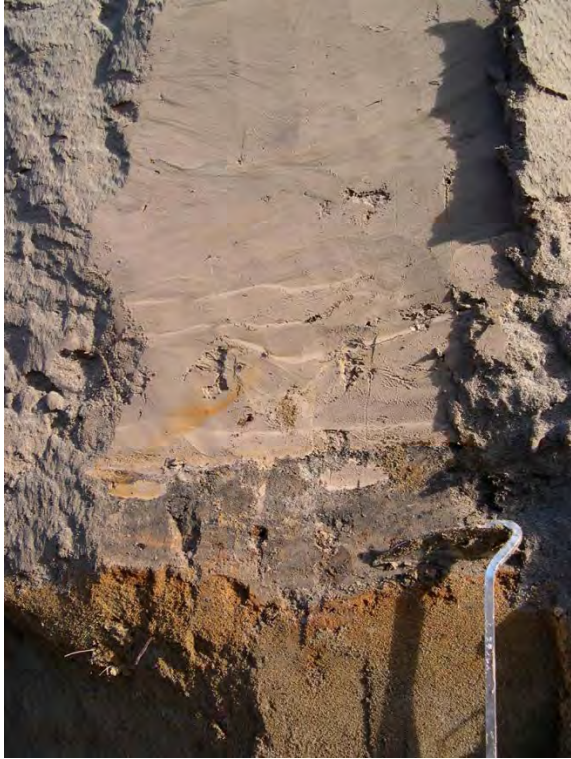
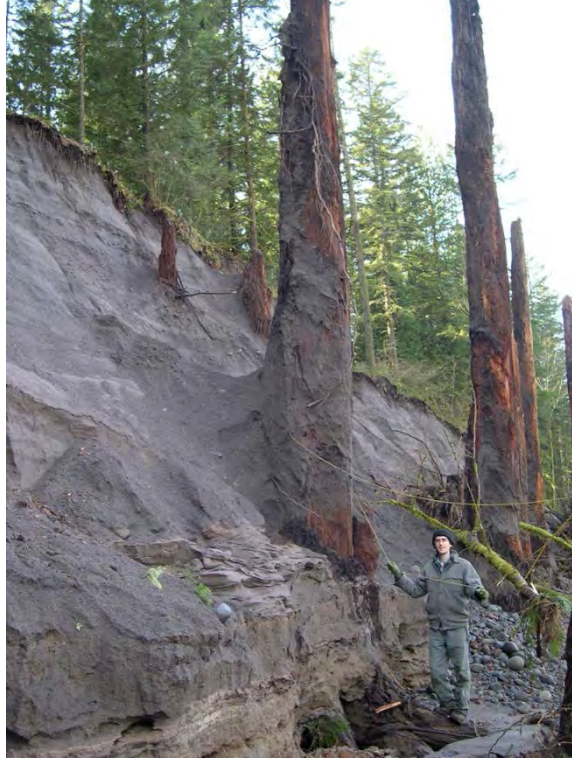
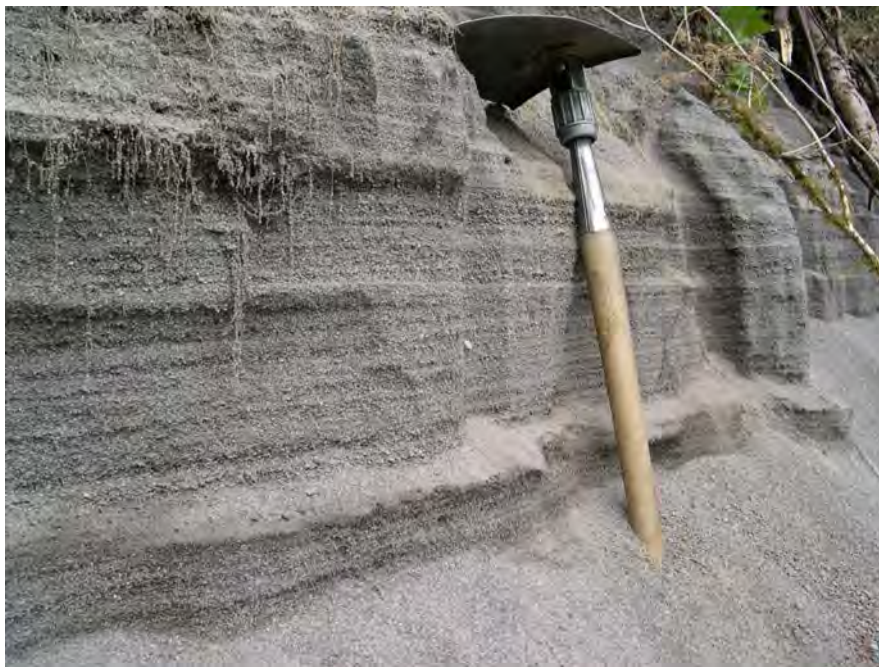
Figure 4. Old Maid deposits on Timberline terrace surfaces: (A) Lithofacies B; (B) Lithofacies A; (C) Lahar at base of section (even with man's midsection); (D) Lithofacies C.

- A. Moderately to well-sorted medium to very fine sand—ripple-cross-laminated, trough-cross-bedded, and massive, commonly capped by a < 1 cm layer of silt—interpreted as overbank flood deposits.
- B. Poorly to moderately sorted medium to coarse sand, locally including fine gravel—trough-cross-bedded, planar-cross-bedded, and ripple-cross-laminated—interpreted as in-channel deposits typical of shallow, braided rivers with moderate rates of sediment transport.
- C. Poorly sorted coarse to very coarse sand, gravelly sand, and sandy gravel—horizontally bedded (with coarse gravel lenses), low-angle cross-bedded, and massive—interpreted as in-channel deposits typical of shallow, braided rivers with high sediment transport rates.

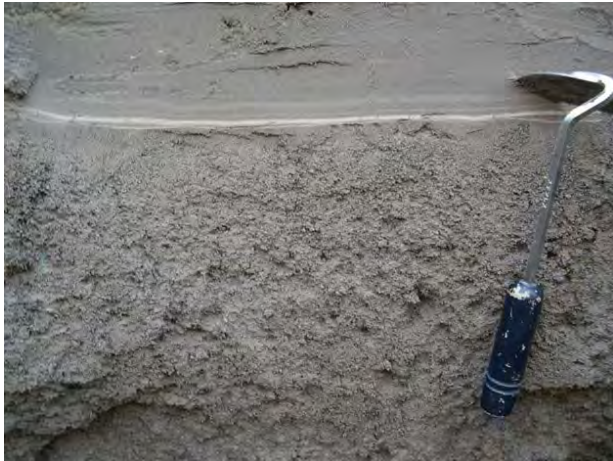
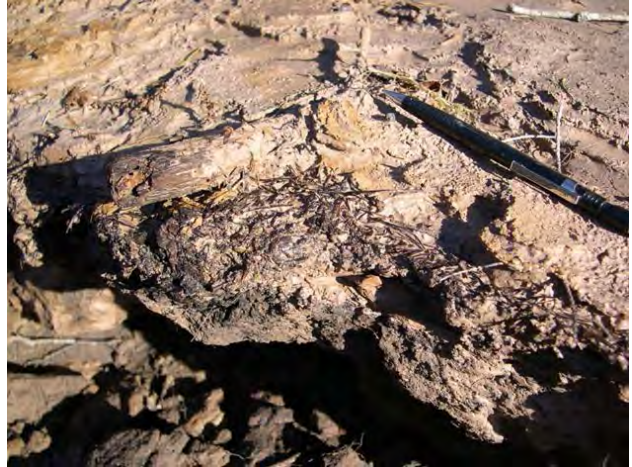
*Figure 5. Old Maid lahar deposit sitting on lowest post-Timberline terrace (A) and reexposed forest litter on higher surface of post-Timberline terrace, which the lahar did not reach (B). Note twigs and hemlock needles (and pen) resting on this buried forest floor, engulfed by overbank flood deposits at the beginning of aggradation.*

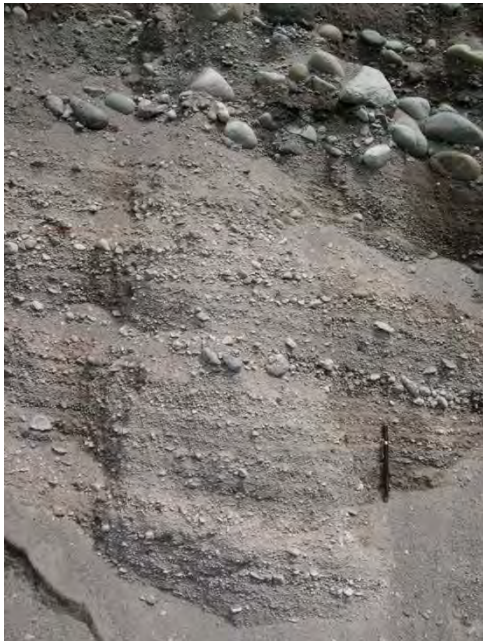
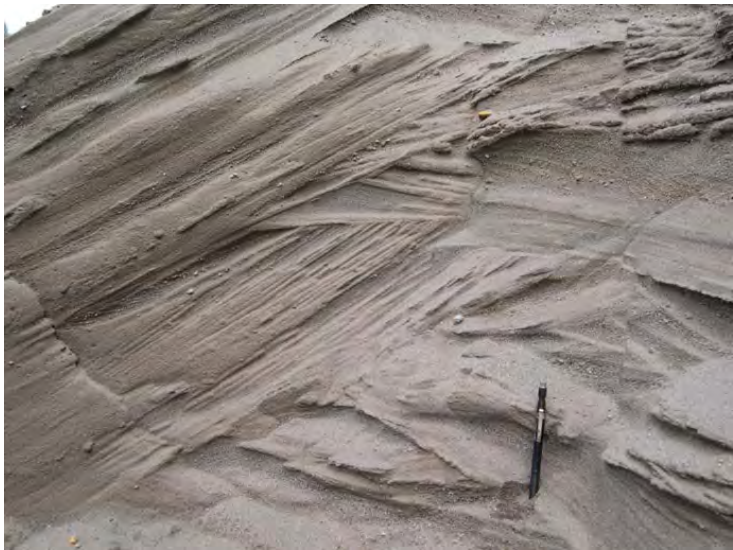
*Figure 6. Variation in fluvial deposits—major component of aggradational sequence: (A) Lithofacies C; (B) Lithofacies B*

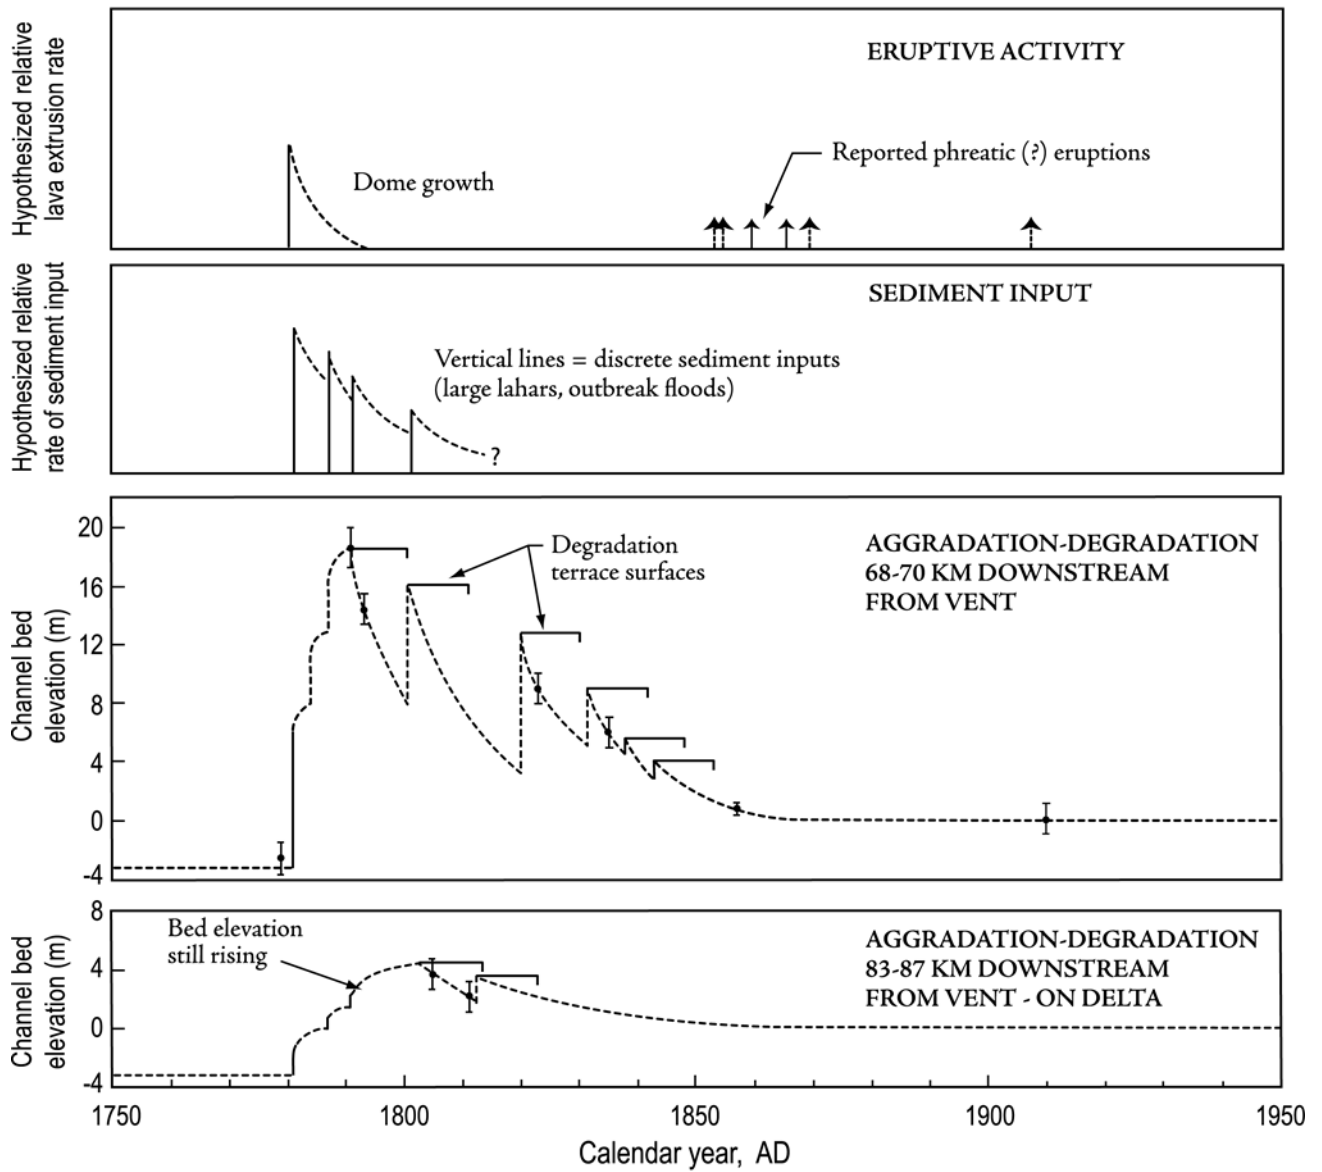
Figure 7. Timing of aggradation/degradation cycle in Sandy River.

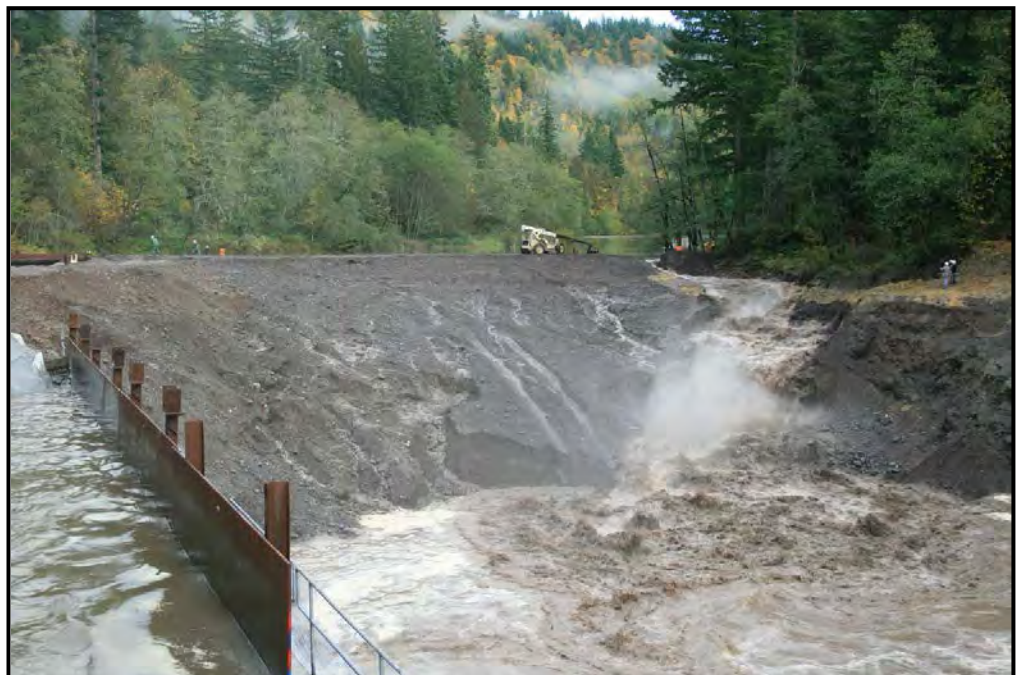
***The party begins....***

Heavy rainfall, a rising river, and a discharge forecast for 68 m<sup>3</sup>/s prompted PGE to begin the breaching process at about 1000 Pacific Daylight Time (PDT) on October 19, 2007. Pumps dewatering the cofferdam and underlying sediment were removed beginning around 1200 PDT. At about 1330 PDT, water began seeping through the earthen dam and triggering small but growing mass failures on its downstream face. At about 1700 PDT, with flow approaching 50 m<sup>3</sup>/s, the cofferdam crest was notched and water began spilling (Major and others, 2010).

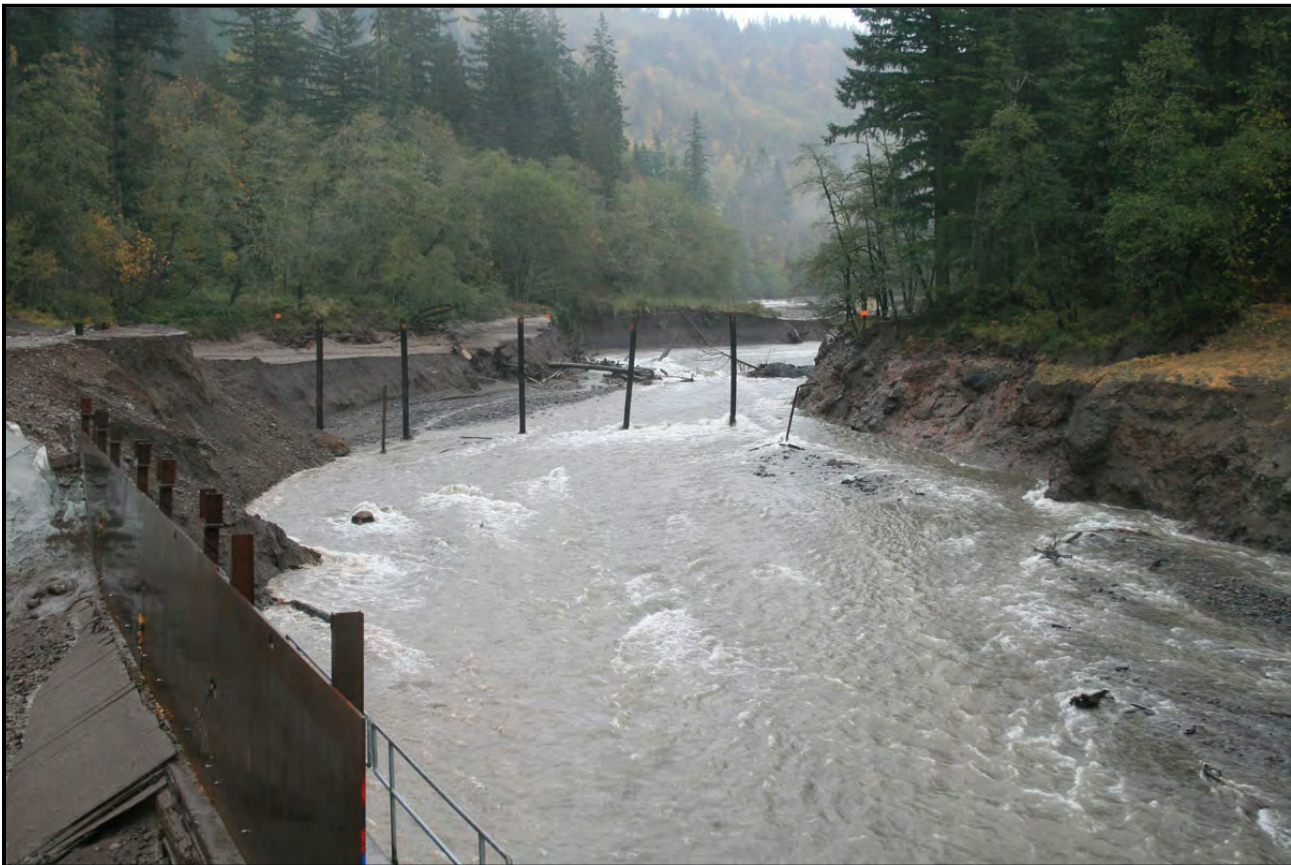
**Figure 2. Knickpoint migration through the reservoir reach following breaching of Marmot Dam. Photographs taken on October 19, 2007, shortly after breaching was initiated show the remnant arcuate knickpoint that advanced toward the north side of the reservoir and the cap of fine sediment that overlies the sand and gravel that composes the bulk of the reservoir sediment. On the lidar image, dates and times of knickpoint position are shown. By October 20, 2007, the knickpoint had diminished to a low-relief riffle. Approximate position of the knickpoint riffle in February and March 2008 were obtained using a handheld Global Positioning System (GPS) during visits between reservoir surveys. Figure 10 from Major and others (2012).**

Reservoir erosion resulted mainly from interactions among knickpoint migration, channel incision, and lateral erosion. Headward erosion began after an approximately 2-m-high knickpoint developed at the dam crest during breaching. The knickpoint split immediately into two arcuate knickpoints that advanced rapidly upstream at meters per minute for the first several minutes. Rapid incision associated with knickpoint passage swiftly formed a narrow channel upstream of the cofferdam along river left, a channel that maintained a nearly constant width for several hours before it progressively widened (Major and others, 2010). The migrating knickpoint advanced 150 m upstream within 50 minutes of breaching of the cofferdam but then slowed substantially, requiring more than 15 hours to advance an additional 250 m.

After the first 60 hours, the knickpoint had evolved to a low-relief (<1 m tall) riffle several meters long. Subsequently, its rate of migration through the reservoir slowed considerably, from tens of meters per day in the first month following breaching to just a few meters per day during the 7- to 12-month period after breaching. By early November 2007, this discontinuity had migrated about 700 m through the reservoir, and by mid-December 2007, following the year's peak discharge, it had migrated about 1 km. About a year after breaching, the riffle had migrated nearly 2 km. Following large storm flows in November 2008 and January 2009, the riffle had migrated farther upstream, but had become less well defined, and its exact position was uncertain because our surveys in January and September 2009

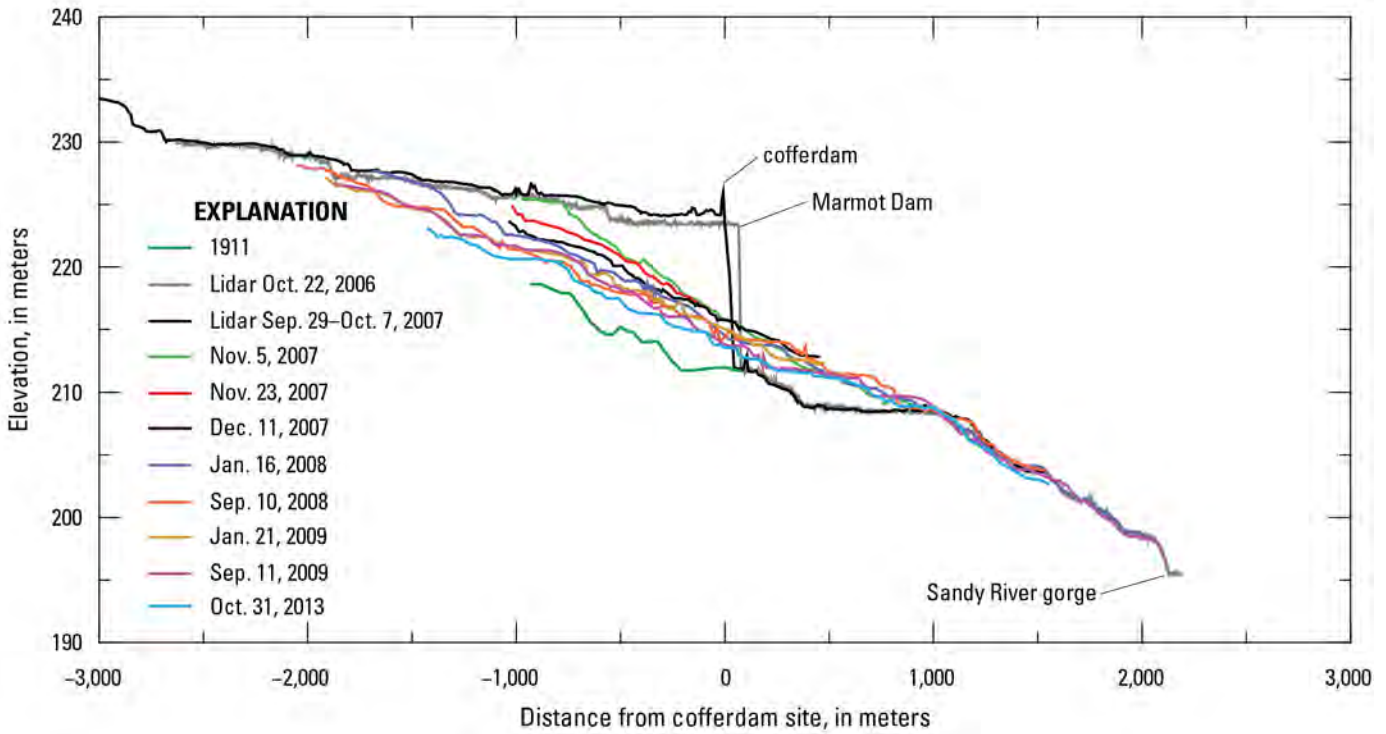
Figure 3. Longitudinal water-surface profiles of Sandy River before and after breaching of Marmot Dam. The water surfaces at times of surveys were generally within one meter of the channel thalweg. Surveyed profiles extend from about 2 kilometers (km) upstream of dam site to about 2 km downstream of dam site. The 2006 lidar profile shows the concrete structure in place; the 2007 lidar profile is of the cofferdam after the concrete dam was removed. The 1911 profile is a triangulate-irregular-network generated reconstruction of topography digitized from a 1911 partial topographic map (Portland General Electric archives) and rectified to create a pre-dam topographic surface. Modified from Figure 14 of Major and others (2012).

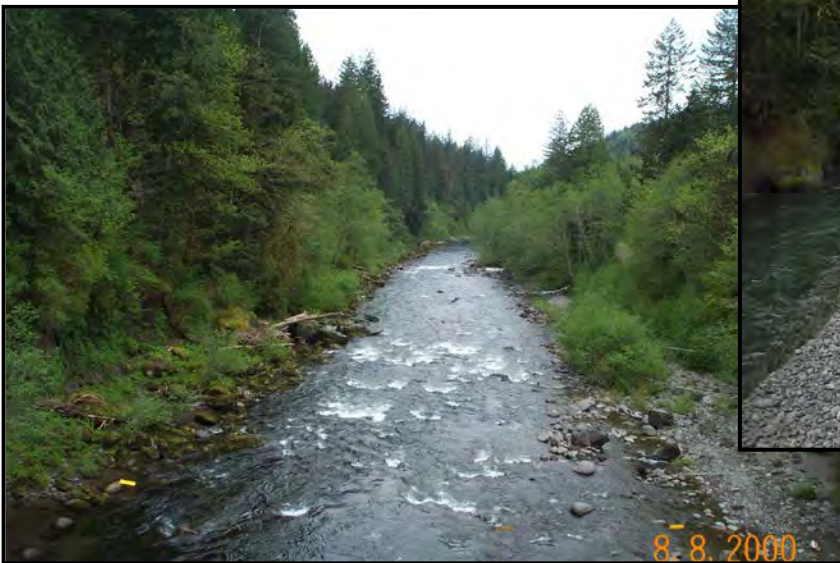
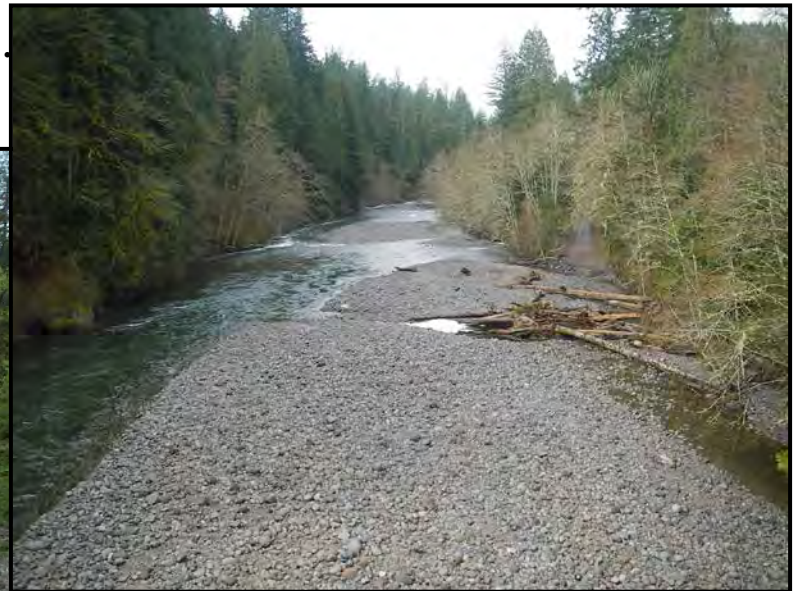
*Before and 5 months after, from the bridge...*

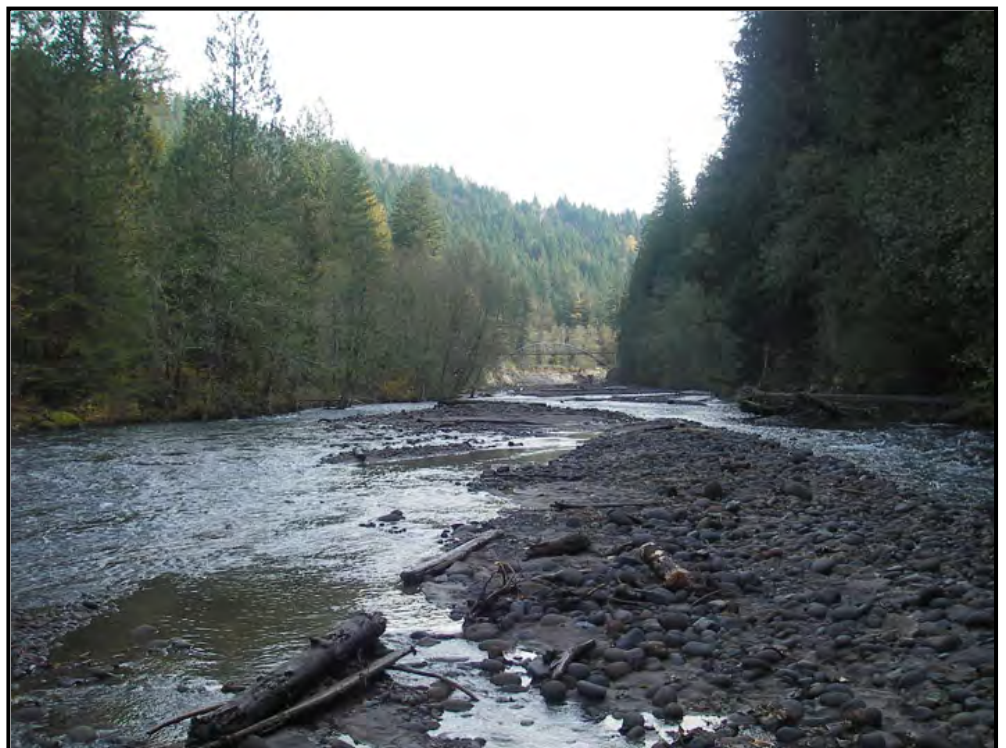
### ***7 November 2007, two weeks after breaching***

After breaching, sediment eroded from the reservoir reach was deposited rapidly along the 2 km of channel and valley bottom between the dam site and the Sandy River gorge. Deposition produced a 1.3-km-long sediment wedge tapering from approximately 4 m thick at the site of the cofferdam to the prebreach channel bed at its distal end. This deposit largely maintained its form for the 2 years following breaching. Over the following 39 hours (through 1200 PDT on October 21), stage (and the channel bed) rose at an average rate of 0.063 m/hr. Consequently, the channel immediately downstream of the dam site transformed rapidly from a single thread, boulder-cobble bed to a multithread channel with a sand-and-gravel substrate flanked by mobile sandy gravel bars.

Surveys and soundings conducted after the initial postbreach survey of November 2007 showed diminished rates of change during the ensuing 2 years as the valley bottom between the site of the cofferdam and the Sandy River gorge evolved from an accumulation zone to a zone primarily of transport. During the first year after breaching, about 30 percent of the approximately 375,000 m<sup>3</sup> of eroded sediment accumulated in the 2-km-long wedge below the dam site; the remainder passed farther downstream. In the second year after breaching, as the rate of reservoir erosion declined markedly, the channel reach immediately below the dam site incised, resulting in net erosion of sediment from the depositional wedge. Differences between channel surveys in 2008 and 2009 showed as much as 1.5 meters of channel incision over a several-hundred-meter-long reach immediately downstream of the dam site and channel soundings at the Marmot Dam measurement station showed a lowering of the mean bed elevation of as much as 0.6 m between December 2007 and September 2009, and incision of the sediment wedge has continued through our last survey in October 2013.

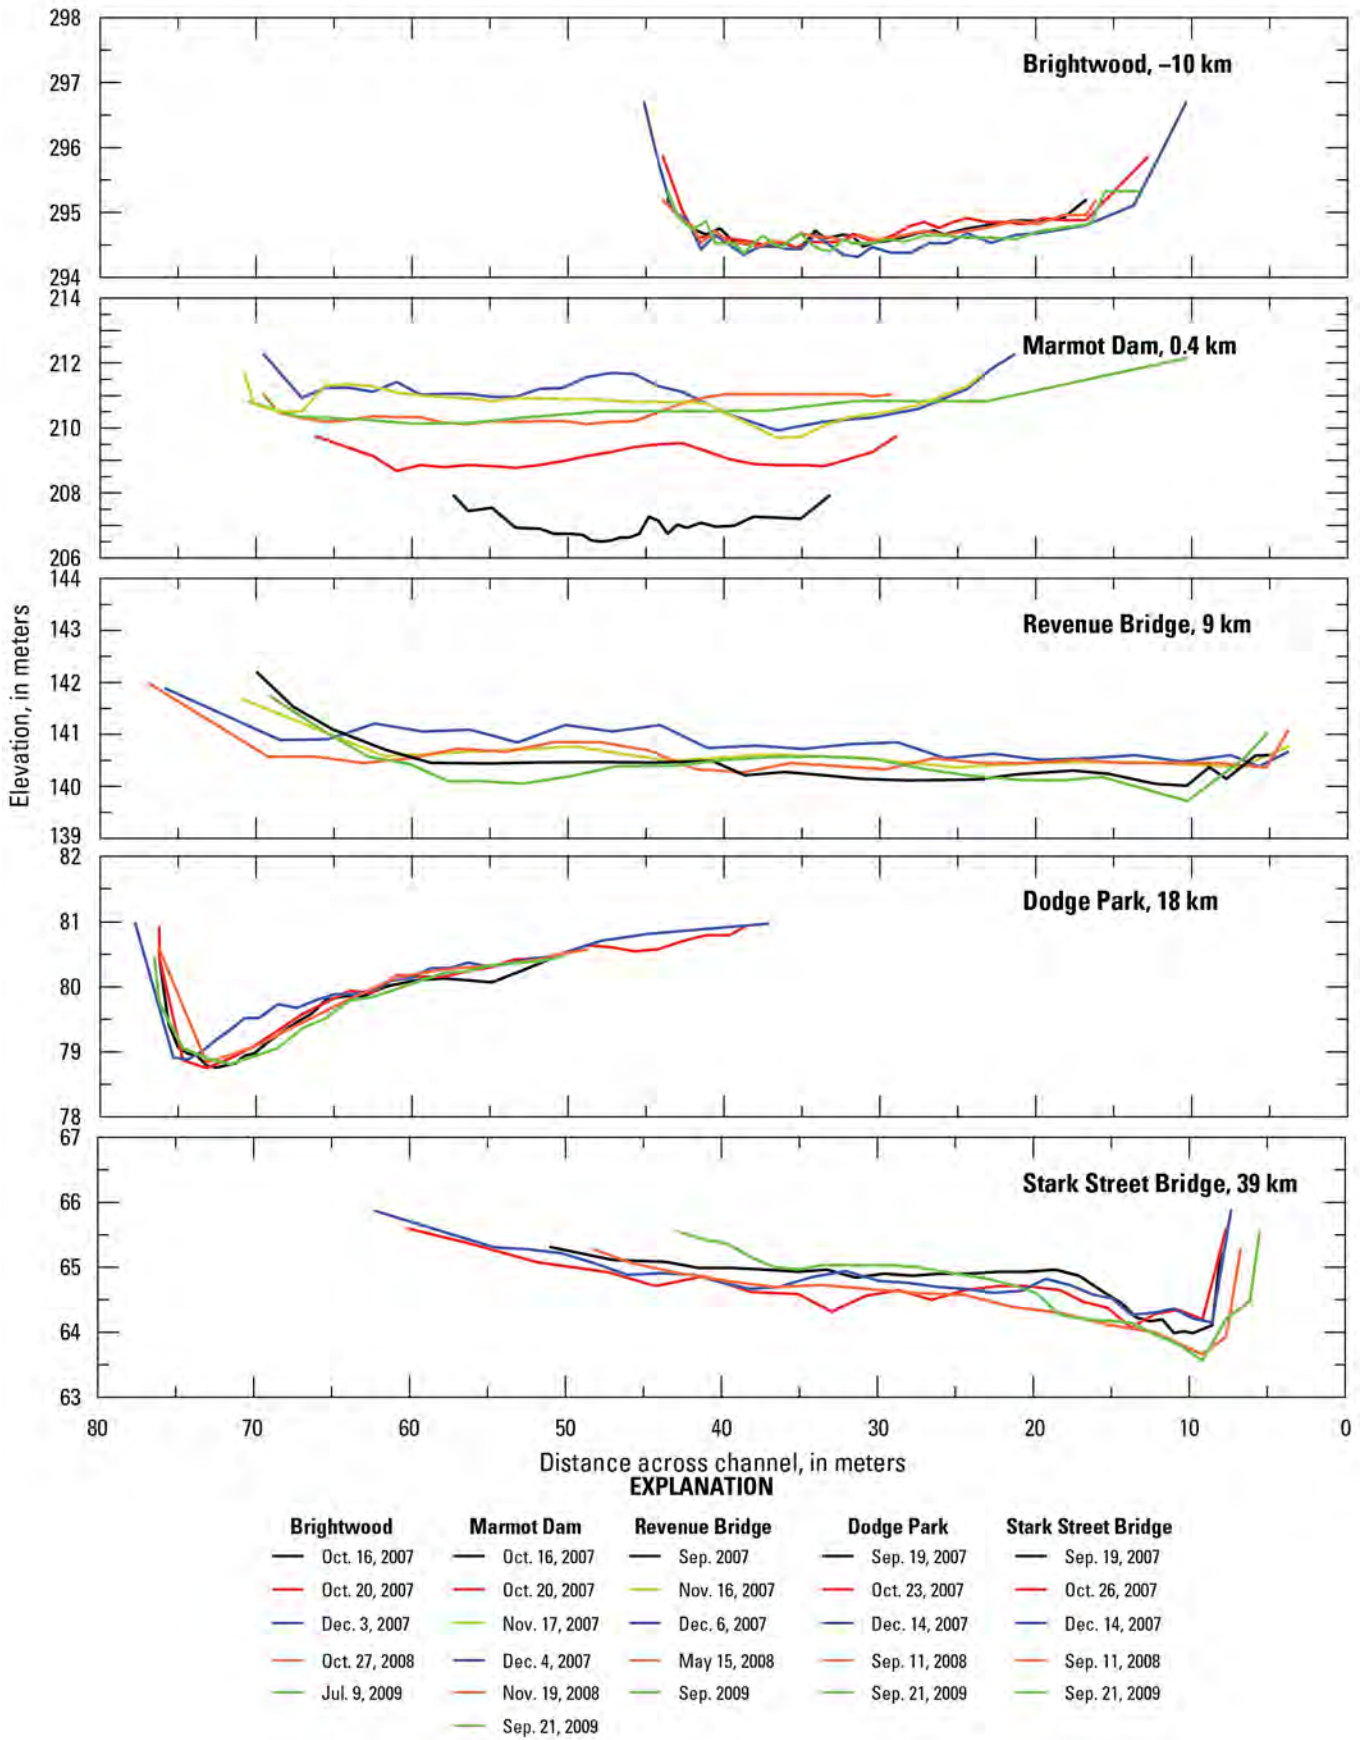
Figure 4. Time series of channel cross-section changes based on soundings at various measurement stations following breaching of Marmot Dam. See figure 1 for station locations. Figure 21 from Major and others (2012).
