Quaternary Geology and Geomorphology of the Lower Deschutes River Canyon, Oregon

Jim E. O'Connor¹, Janet H. Curran², Robin A. Beebee³, Gordon E. Grant⁴, and Andrei Sarna-Wojcicki⁵

Geology and Geomorphology of the Deschutes River, Oregon
Water Science and Application 7

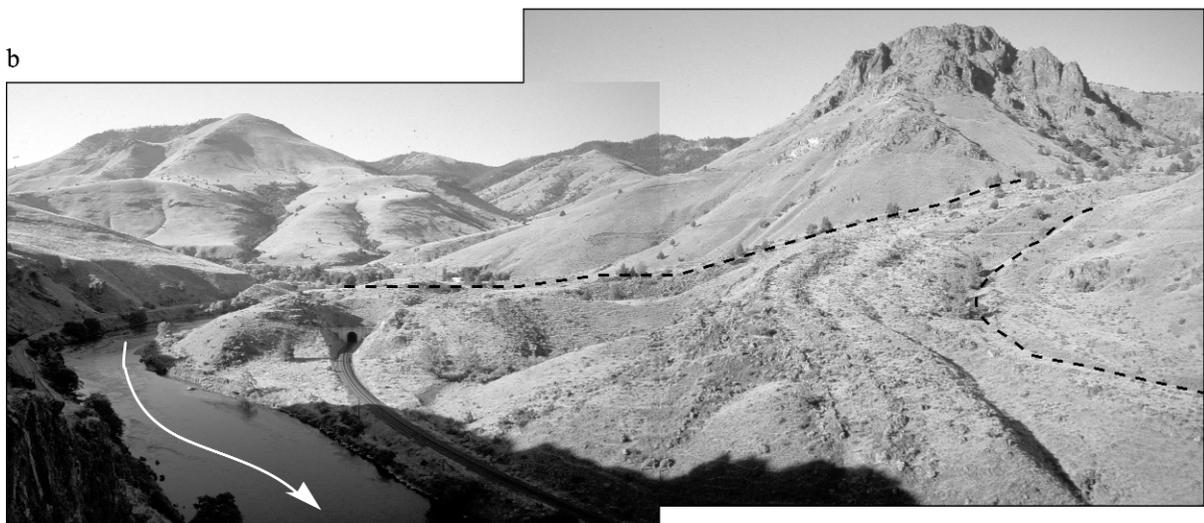
Figure 8. Dant debris flow. (a) Vertical aerial photograph (1995, Portland General Electric) showing flow deposit and inferred source area. (b) Two-photograph panorama directed upstream (south) showing terminus of flow deposit. Railroad and tunnel indicate scale. July 17, 1998, photographs by J. H. Curran.

Dant debris flow. Another mass movement blocked the Deschutes River channel near the present-day vacation community of Dant at RM 64 (Figure 8). This mass movement has a flow-like morphology, with 5- to 10-m-high sub-parallel ridges aligned with the apparent flow direction for the lowermost kilometer of the deposit. The flow deposit is not traceable to a distinct mass movement or head scarp, but emerges from 1 km² of terrain that presumably partly collapsed. Like the Whitehorse Rapids landslide, the source area of the Dant debris flow is entirely within the John Day Formation.

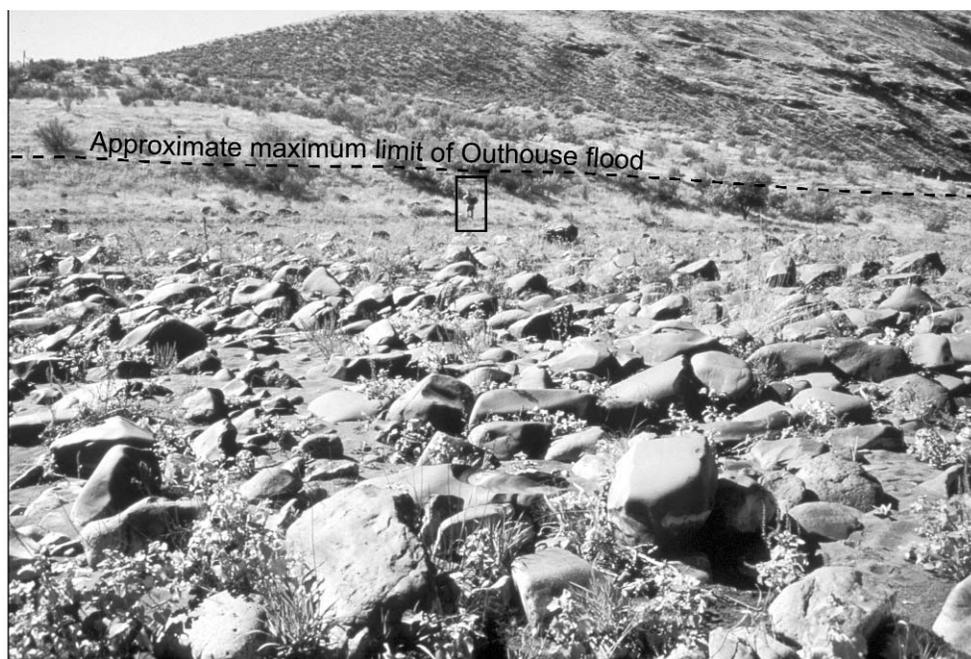
Figure 13. Boulder gravel of an Outhouse flood bar on the left bank at RM 4.2. Intermediate diameters of most boulders between 30 and 50 cm, but some intermediate diameters exceed 1 m. Sand between boulders deposited by the February 1996 flood, which inundated the bar to the elevation at which the person is standing, approximately 4 m lower than the prominent trim-line inferred to have been formed by the Outhouse flood. October 2, 1998 photograph by J. H. Curran.

surfaces away from the main channel. A common depositional location is on the upstream ends of Outhouse flood bars (Figure 13). In these settings, high flows ramp up and slacken against the ascending bar surface. During the February 1996 flood, silt, sand, gravel, and much of the large wood carried by the flood was stranded on the upstream ends of many of these large bars. Wood accumulations locally impeded or concentrated flow, controlling patterns of scour and deposition of these surfaces. These alluvial surfaces may serve as the major sediment storage sites for sand and silt transported into and down the Deschutes River canyon. The sporadic accumulation and release of fine sediment depends on the sequence of flows, flow duration, suspended sediment and wood abundance, vegetation conditions, and the local hydraulic environment. Only the rare floods of magnitude similar to that of February 1996 are large enough to inundate these surfaces and cause significant sediment mobilization.

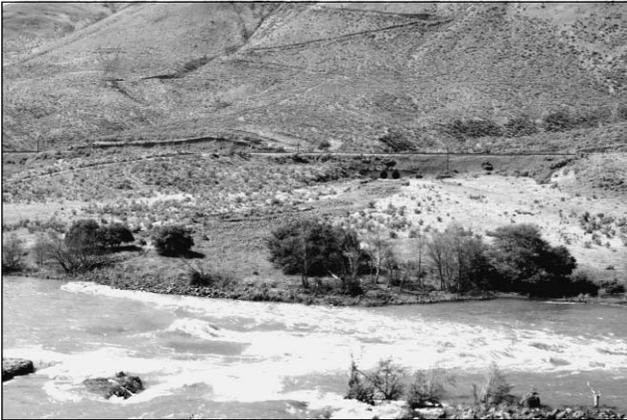
Figure 15. View north of the tributary fan at RM 7.8, where a July 1995 debris flow transported bouldery gravel into the Deschutes River channel, forming 'Washout Rapids.' Culverts under railroad have diameters of 4 m. June 2, 1998 photograph by J. E. O'Connor.

they are local sources of readily-mobilized coarse-grained sediment. According to Steve Pribyl (Oregon Dept. of Fish and Wildlife, oral communication, 1998), the fan emanating from the Harris Canyon tributary (RM 12) has repeatedly encroached into the Deschutes River channel over the last decade, only to be trimmed back several times by large mainstem flows. Just downstream, the apex of Harris Island has accumulated angular basalt gravel and cobbles that likely derive from the Harris Canyon fan. *Curran and O'Connor* [this volume] more fully discuss locations, sizes, and distribution of tributary fans.
