The 1786 earthquake-triggered landslide dam and subsequent dam-break flood on the Dadu River, southwestern China

F.C. Dai^{a,b}, C.F. Lee^{b,*}, J.H. Deng^c, L.G. Tham^b

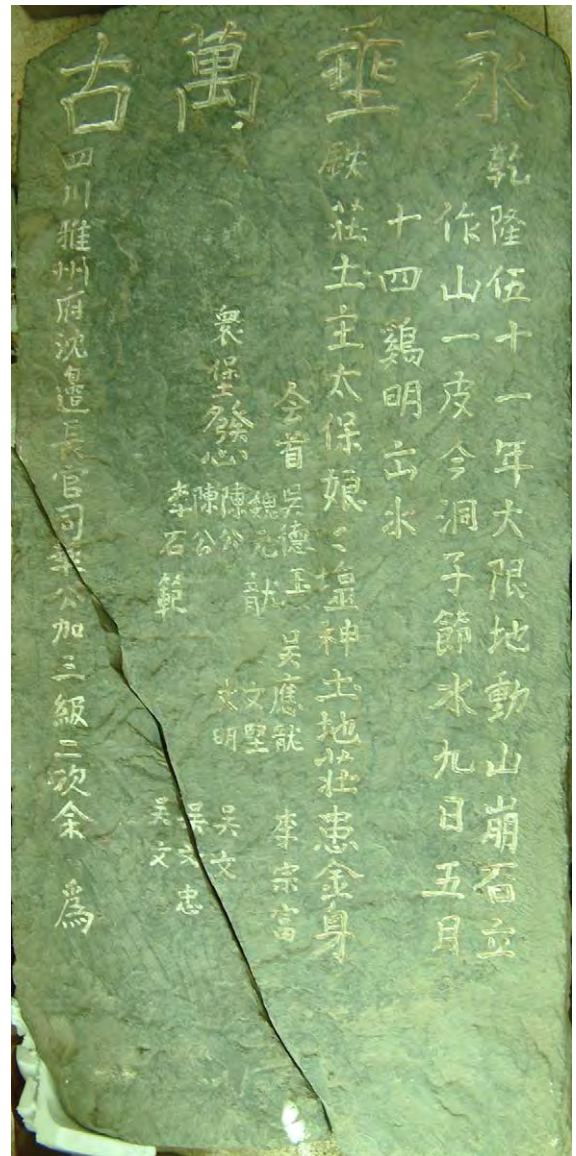
Fig. 3. The monument created by local residents in memory of the landslide-damming event. For interpretation, refer to the main text.

Apart from the Bao Ning report, a monument was created by local residents in memory of this event. The monument (Fig. 3), now kept at the Luding Seismological Office, is a stone tablet with the following inscription in Chinese (Zheng, 1998): "In 1786, the ground shook and the rocks collapsed. The mountain at Jindongzi collapsed and a landslide dam blocked the Dadu River for nine days. In the early morning on June 9, water in the lake overflowed the crest of the dam."
