EXPERIMENTAL INVESTIGATION OF THE FAILURE OF CASCADE LANDSLIDE DAMS*

Abstract: This paper presents results of model tests for the landslide dam failure of a single dam and cascade dams in a sloping channel. The dams were designed to be regular trapezoid with fine sand. A new measuring method named the labeled line locating method was used to digitalize the captured instantaneous pictures. Under two different inflow discharges, the morphological evolution and the flow patterns during one dam failure and the failure of cascade dams were investigated. The results indicate that when the inflow discharge is large, the deformation pattern of the downstream dam is similar to that of the upstream dam, and both dams are characterized with the overtopping scour throughout the dam failure process. When the inflow discharge is small, the upstream dam is scoured mainly through a sluice slot formed by the longitudinal incision, and the downstream dam is characterized with the overtopping scour. The data set presented in this paper can be used for the validation of numerical models and provide a reference for the flood risk management of cascade landslide dams.

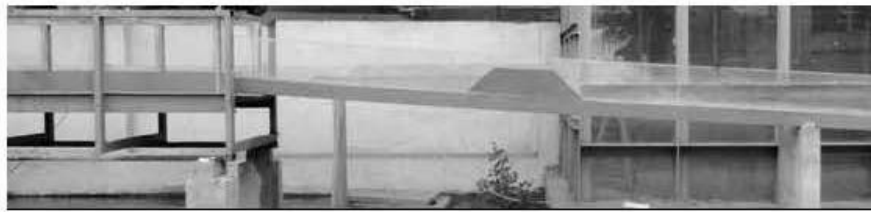
(a) Picture view of single dam laboratory experiment

(b) Sketch map of single dam failure experiment

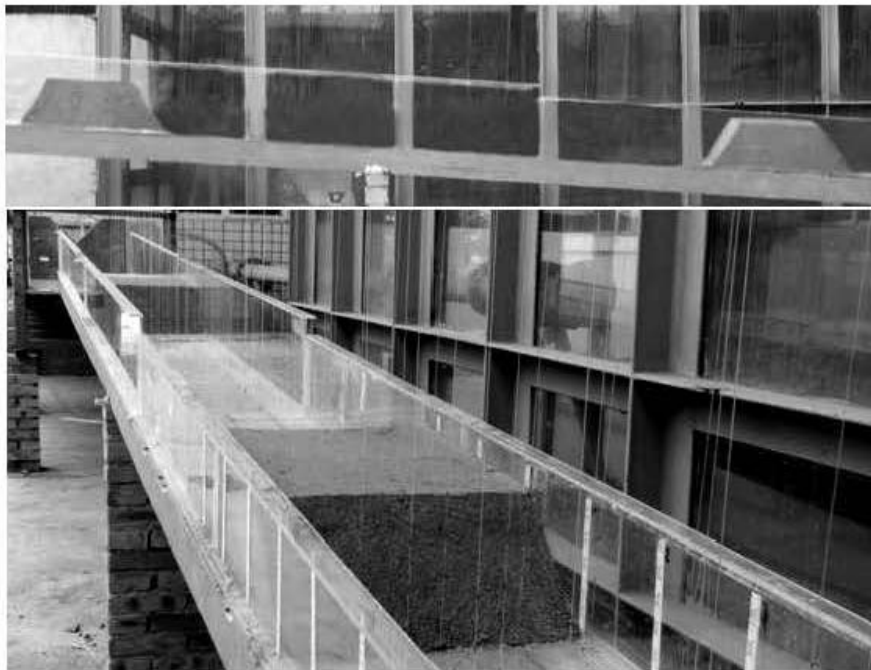
(c) Picture views of cascade dams laboratory experiment layout

(d) Sketch map of cascade dam failure experiment layout

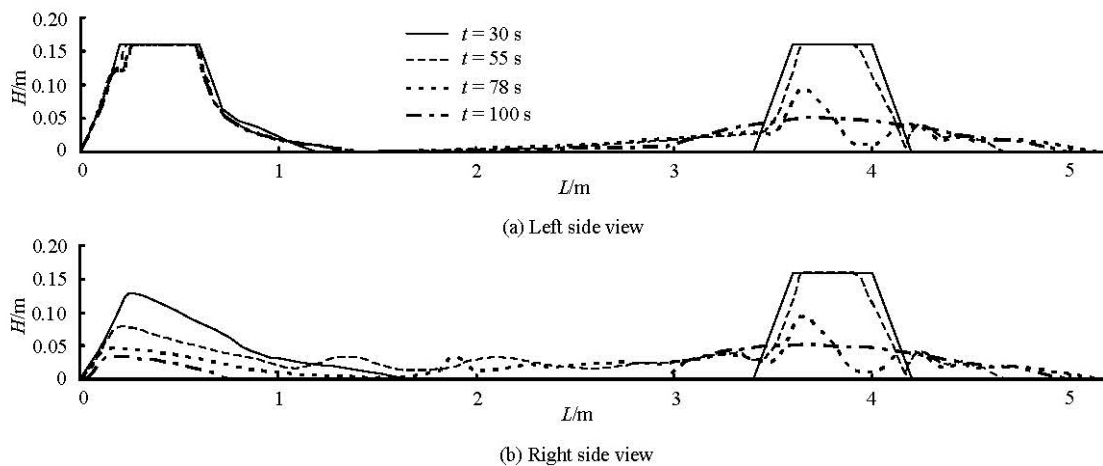
Fig.6 Dynamic changes in height of the dam and bed deposition at different times

the dam. The reflected sediment-laden water has no significant effects on the dam-break process of the upstream dam due to the long interval between the two dams. However, the sediment-laden water that flows over the downstream dam would cause a drastic erosion of the dam because the discharging flow from the upstream dam features large discharge and quick flow. Unlike the dam-break process of the upstream dam, the dam failure of the downstream dam does not experience the breach formation process, but starts the lateral uniform scouring of the dam's downstream face. The deposition is accumulated below the downstream dam. An indentation and hydraulic jump in the indentation appears and moves upwards as the scouring process continues. About 100 s later, the downstream dam is nearly swept away. The time evolution of the dam and the bed deposition profile is shown in Fig.6. The dam depositions with water profiles at different times are illustrated by data graphs in Fig.7.
