Restoring earth surface processes through landform design. A 13-year monitoring of a geomorphic reclamation model for quarries on slopes

ABSTRACT: The application of geomorphic principles to land reclamation after surface mining has been reported in the literature since the mid-1990s, mostly from Australia, Canada and the USA. This paper discusses the reclamation problems of contour mining and quarries on slopes, where steep gradients are prone to both mass movement and water erosion. To address these problems simultaneously, a geomorphic model for reclaiming surface mined slopes is described. Called the 'highwall–trench–concave slope' model, it was first applied in the 1995 reclamation of a quarry on a slope (La Revilla) in Central Spain.

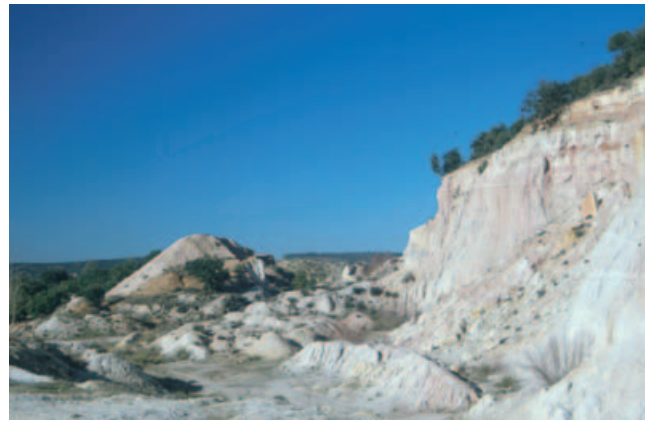
Figure 1. The abandoned silica sand quarried slope of La Revilla, before its geomorphic reclamation: appearance of the exploited quarry at the slope of a limestone-capped small mesa, and highwall–bench–outslope topography, with a chaotic arrangement of scarce silica sand and clay spoils.

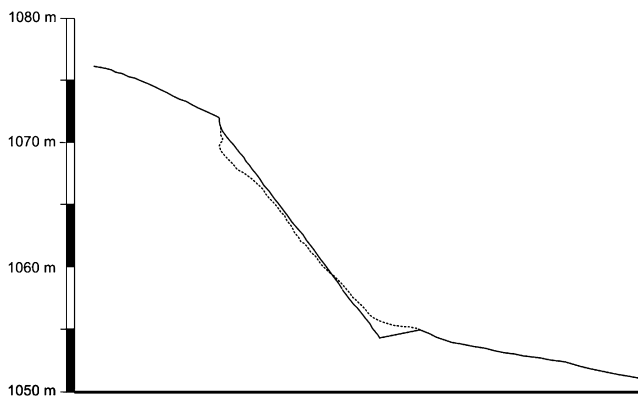
Figure 6. Highwall's profiles comparison: 1995 (dark-rectilinear line), 2007 (dotted-irregular line).

parison of a profile of the highwall–trench sector. The difference in the appearance of Figure 5A and 5B, and of the stroke of the profile lines (Figure 6), is due to the different precision of the topographical instruments.
