The formation and failure of natural dams

JOHN E. COSTA *U.S. Geological Survey, Cascades Volcano Observatory, 5400 MacArthur Boulevard, Vancouver, Washington 98661*
ROBERT L. SCHUSTER *U.S. Geological Survey, M.S. 966, Denver Federal Center, Lakewood, Colorado 80225*

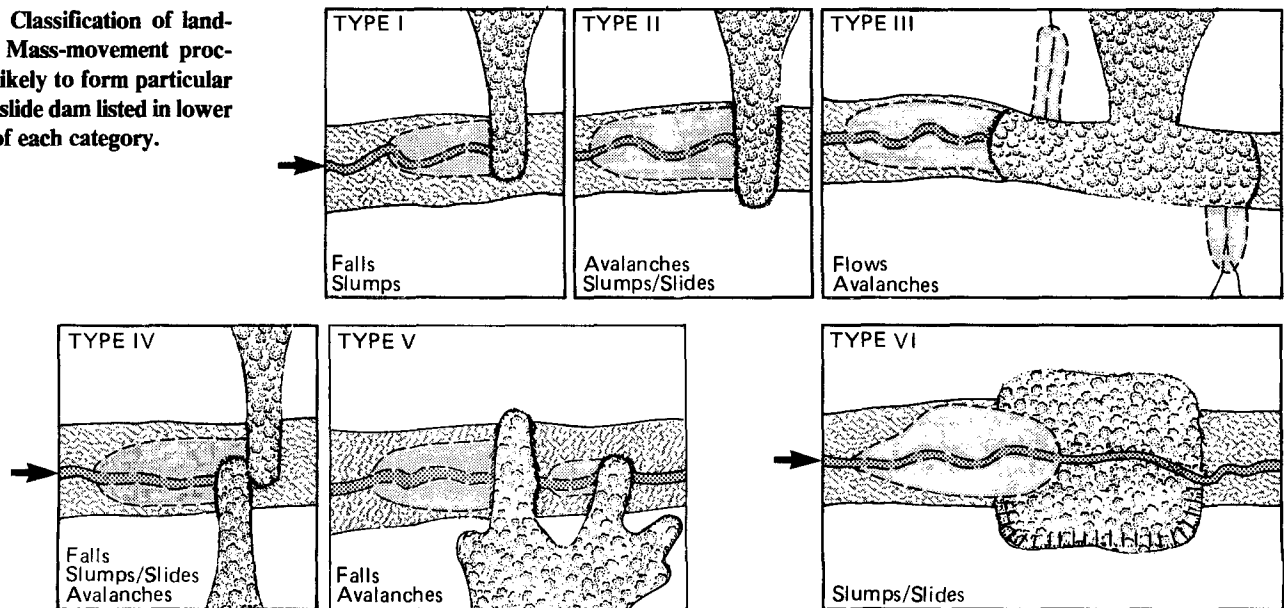
Figure 3. Classification of landslide dams. Mass-movement processes most likely to form particular kind of landslide dam listed in lower left corner of each category.

Landslide dams can be classified geomorphically with respect to their relations with the valley floor (Swanson and others, 1986) (Fig. 3). Type I dams are small in contrast to the width of the valley floor and do not reach from one valley side to the other. Type II dams are larger and span the entire valley floor, in some cases depositing material high on opposite valley sides. Type III dams fill the valley from side to side, move considerable distances upvalley and downvalley from the failure, and typically involve the largest volume of landslide material. Type IV landslide dams form by the contemporaneous failure of material from both sides of a valley. The landslides can adjoin head-to-head in the middle of the valley, or they can juxtapose one another. Type V landslide dams form when the same landslide has multiple lobes of debris that extend across a valley floor and form two or more landslide dams in the same reach of river. Type VI landslide dams involve one or more failure surfaces that extend under the stream or river valley and emerge on the opposite valley

Of 184 landslide dams classified from around the world, the most common are types II (44%) and III (41%). The other types are much more infrequent (type I = 11%, type IV and type V = < 1%, and type VI = 3%). Type I landslide-dam lakes commonly are small, shallow, and in most cases not hazardous. Type II landslide-dam lakes are larger and much more dangerous. Type III dams, in addition to forming large hazardous lakes behind the obstruction, can also block tributaries to the main valley, creating additional potentially dangerous lakes. This is the case at Mount St. Helens, Washington, as a result of the 1980 debris avalanche that dammed tributaries to the North Fork Toutle River. Type IV and V landslide-dam lakes can be hazardous if the valleys are narrow and the landslide volumes large enough to form high dams. Only one example of a type IV landslide dam is known, the Yinping landslide blockage of the Min River, Sichuan Province, China, which forms Da Lake (Li and others, 1986) (Fig. 4). Only one example of a type V landslide dam is known, the Slide Lake rockfall-avalanche in Glacier National Park, Montana (Butler and others, 1986). A few examples of type VI landslide dams are known

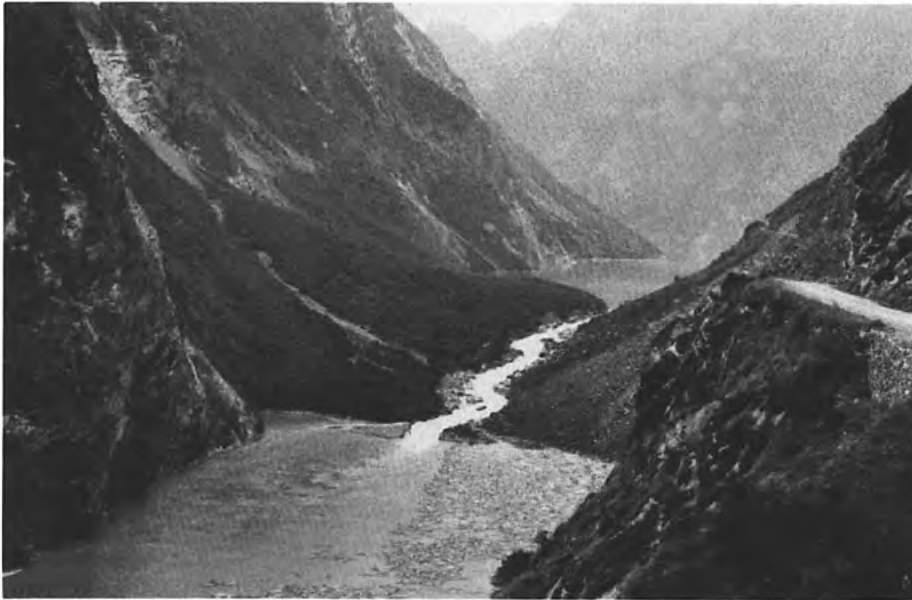
Figure 4. Photograph of view upstream along the Min River, Sichuan Province, People's Republic of China, at the remains of the 1933 earthquake-induced Yinping landslide dam, which impounded Da Lake (middle background). Xiao Lake (foreground) was impounded by another landslide dam caused by the same earthquake.

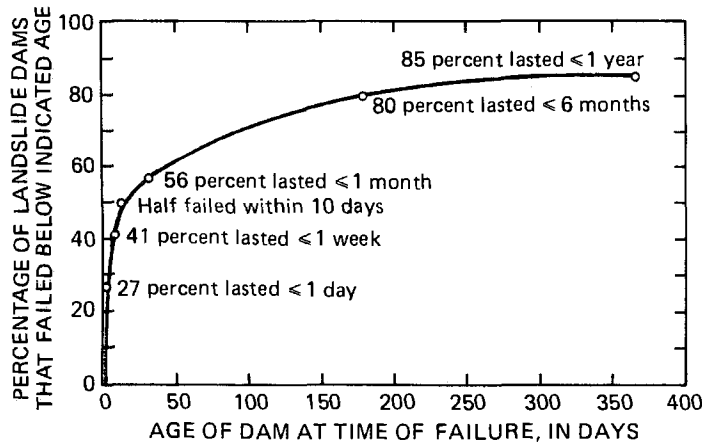
Figure 6. Length of time before failure of landslide dams, based on 73 cases from the literature and the authors' experience.

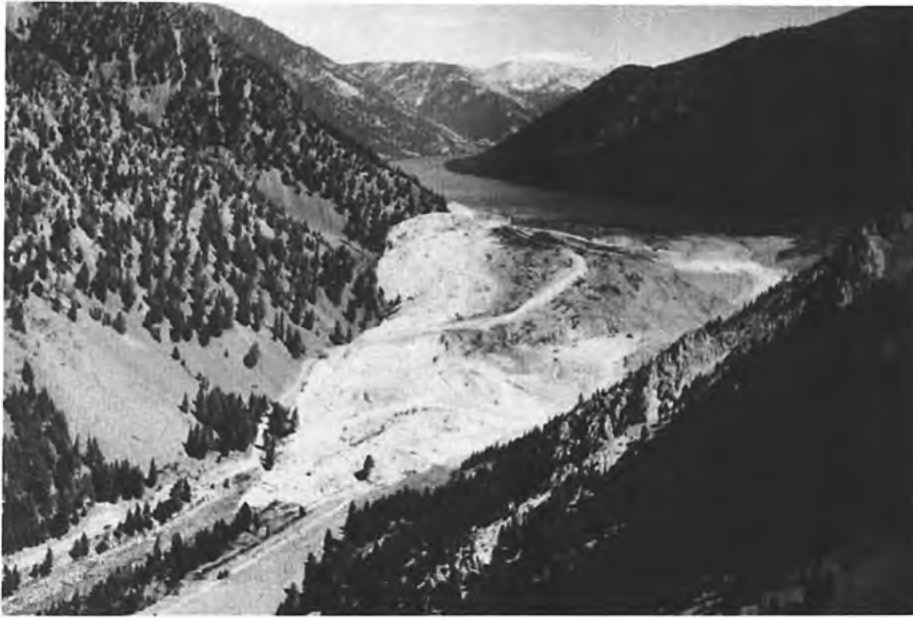
Figure 7. Photograph of the landslide dam formed by the 1959 Madison Canyon landslide, Montana, and of Earthquake Lake, which it impounds. (Photograph by J. R. Stacy, U.S. Geological Survey.)

The simplest and most common method for stabilizing landslide dams has been construction of channelized spillways either across adjacent bedrock abutments or directly over the landslide dams. A well-known example of a successful spillway across a landslide dam is the spillway constructed in 1959 by the U.S. Army Corps of Engineers on the Madison Canyon landslide, Montana (Harrison, 1974) (Fig. 7).

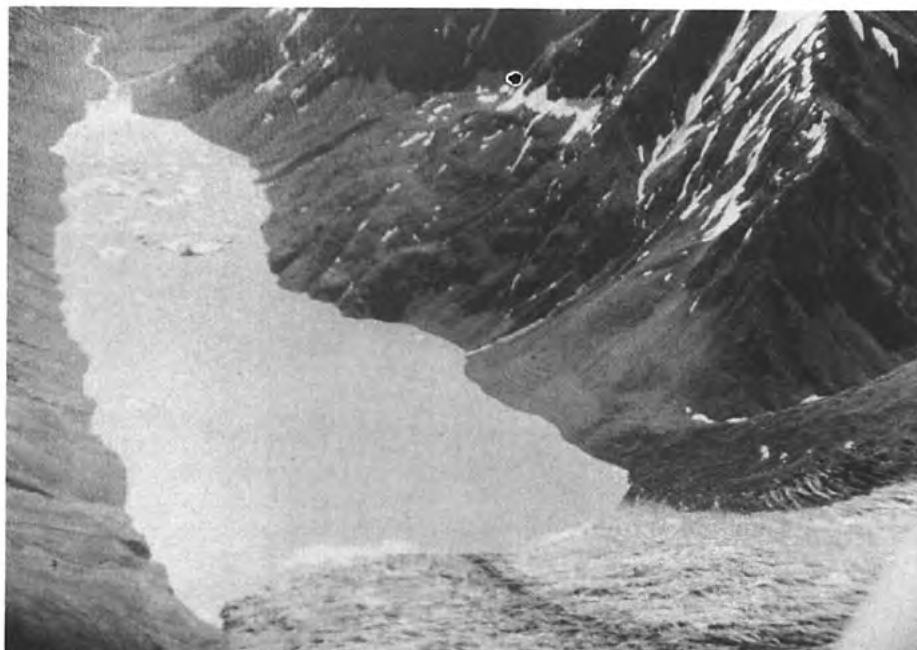
Figure 8. Photograph of a glacier-dammed lake in a tributary valley (type D, Table 4), Coast Mountains, Alaska. Note the strand lines indicating previously higher lake levels. (Photograph by W. C. Bradley, University of Colorado.)

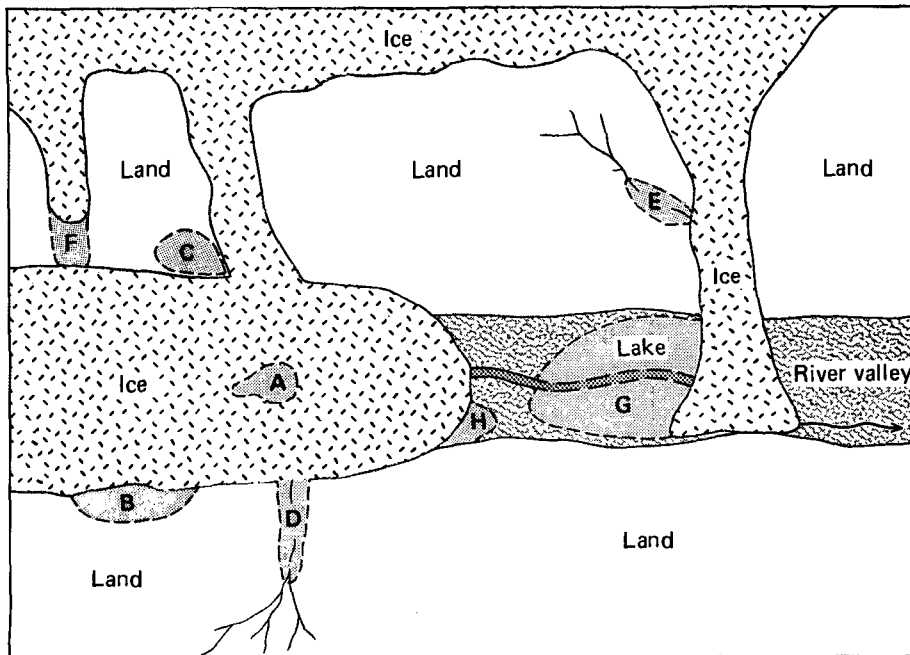
Figure 9. Classification of glacial-ice dams, keyed to Table 4.

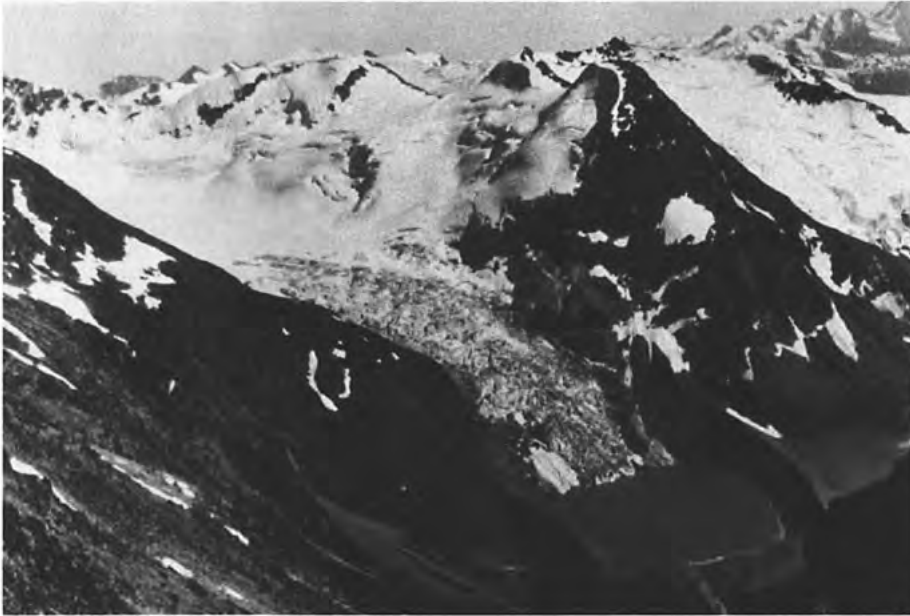
Figure 10A. Photograph of Nostetuko Lake, a neoglacial moraine-dammed lake, 1977. (Photograph by J. M. Ryder, courtesy of Michael Church, University of British Columbia.)

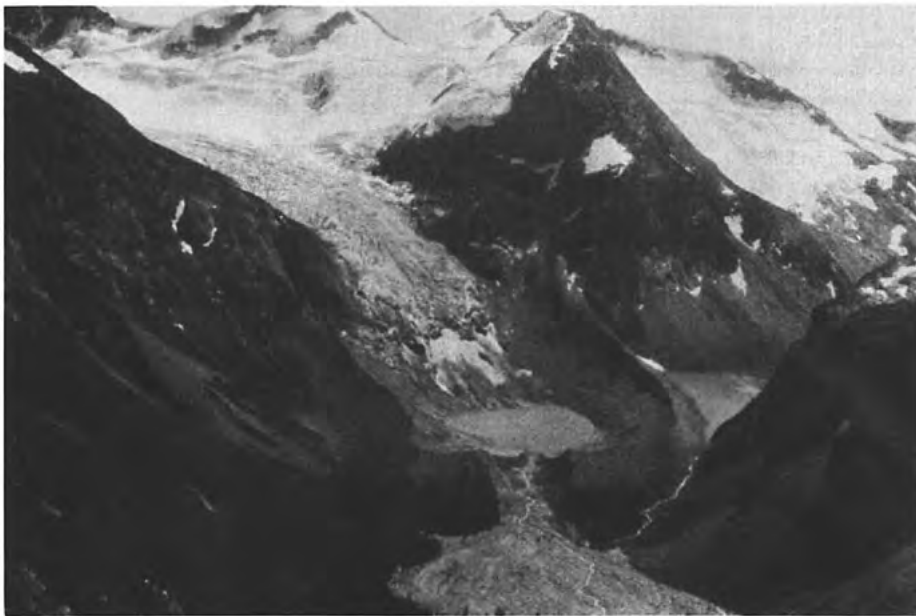
Figure 10B. Photograph of Nostetuko Lake and Cumberland Glacier, British Columbia, Canada, in August 1983, after failure of the moraine dam. Cross section of dam shown in Figure 13. (Photograph by Michael Church, University of British Columbia.)

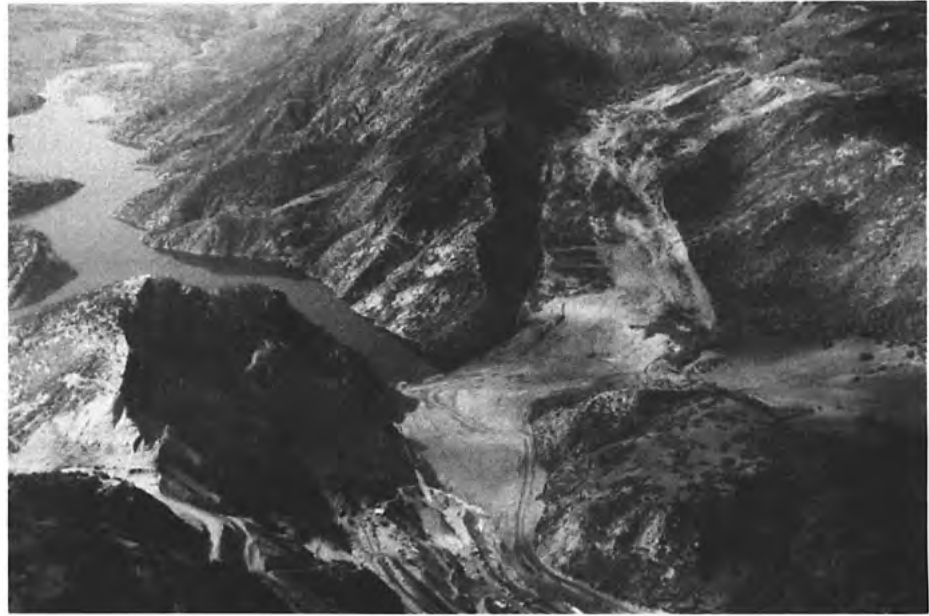
Figure 11. Photograph of the 1983 Thistle, Utah, landslide (right) and its temporary impoundment, Thistle Lake (left), in September 1983. The lake inundated the town of Thistle and was then drained late in 1983 by a bedrock tunnel constructed through the mountain at lower left.

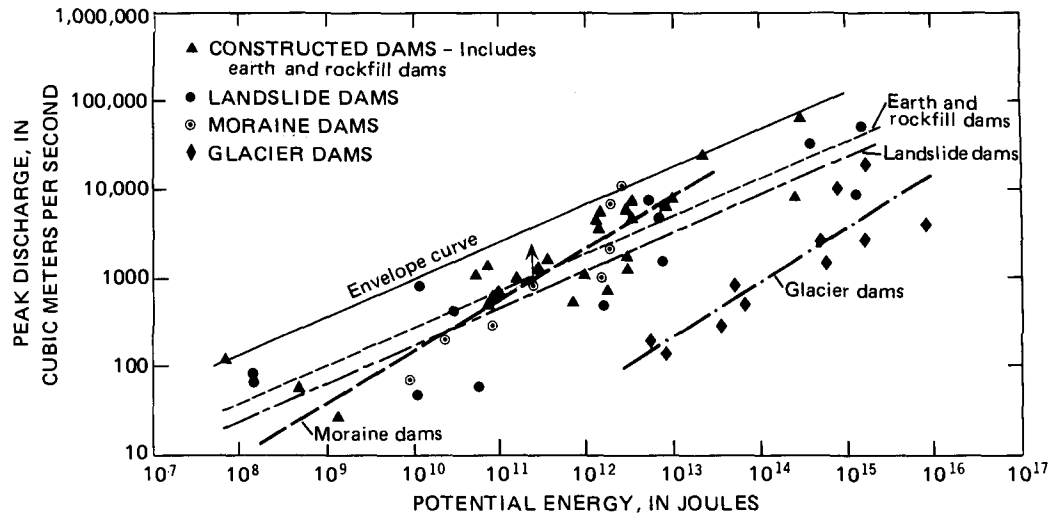
Figure 12. Graph showing potential energy of lake water versus peak discharge for various types of dam failures. Dashed lines are least-squares regression lines for different kinds of dams. Solid line is the envelope curve for all dam-failure data. Data from Costa (1985) and Tables 2, 3, and 5.

For the same potential energy at the time of dam failure, glacier dams produce the smallest peak discharges. For potential energy less than about 10¹¹ joules, constructed earth- and rock-

fill dams produce the largest peak discharges for a constant potential energy. For potential energy greater than about 10^{11} to 10^{12} joules, moraine-dam failures produce the largest peak discharges for a constant potential energy. Differences in peak discharges for constant potential energy of different kinds of natural and constructed dams originate partly because of differences in failure mechanisms, which are related to geometry and to material characteristics of the dams (Table 7).
